## MODIFICATIONS

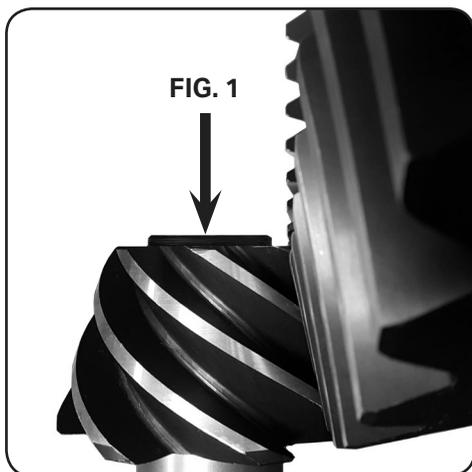
In some instances pinion gears (factory or aftermarket) extend excessively inward towards the differential's center. This can result in contact with the GRIP unit by either the protruding portion of the pinion's end (FIG. 1) or the actual outside edge of the pinion's gear teeth (FIG. 2). If this happens to be the situation, then it is vitally important that the outermost face of the pinion gear be modified to create the necessary clearance for the assembly to function properly.

**NOTE:** If measured clearance of less than 0.5mm (0.020") between the GRIP unit and the pinion gear exists, then unwanted contact between the two could occur when the assembly flexes under high torque application.

Before doing ANY modifications, record the pinion depth. This is typically found on the end of the pinion (FIG. 3). Then, either machine the end of the pinion gear to the desired measurement or grind a small section of the outside edge of the pinion gear's teeth if needed. If any alteration has been made to the overall length of the pinion at this point, add the length removed to the original pinion depth. Mark this number on the pinion as the new pinion depth.

Under no circumstances should modifications of any kind be made to the GRIP unit to create clearance as this will weaken the GRIP unit and void any warranty.
