68RFE ProTect68 Plate Kit

1030373 | 2007-2018 68RFE Transmission

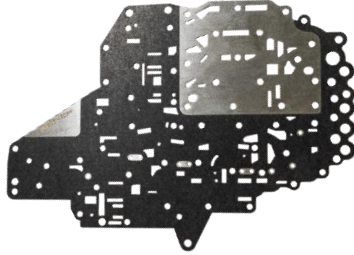
Clutch Feed Seal Qty: 3	Gasketed; Separator Plate Qty: 1

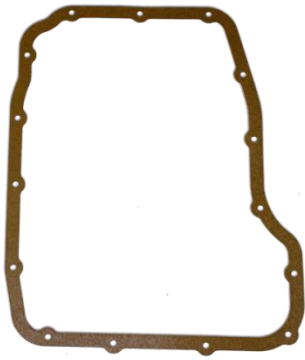
Gasket Qty: 1	1/4" Check Ball Qty: 2	Accumulator Plate Qty: 1

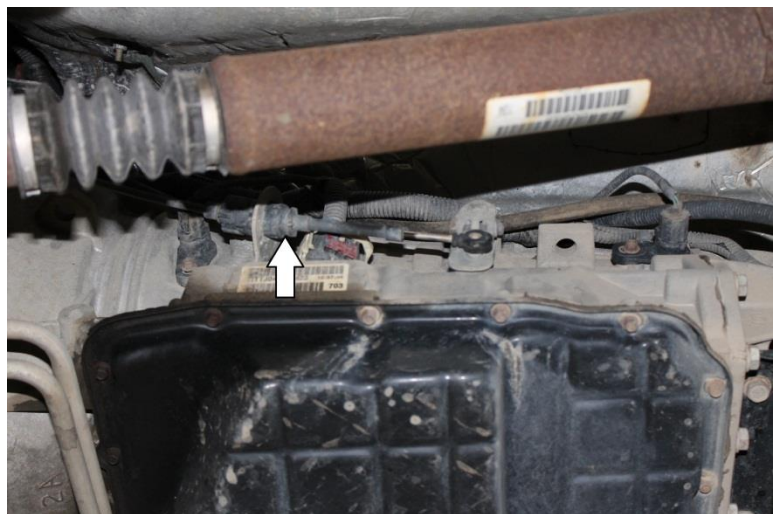
6. To remove connector, push red tab (1) downwards. Then, press the black tab (2) which will allow the white handle (3) to be rotated downwards, releasing the connector from the transmission.

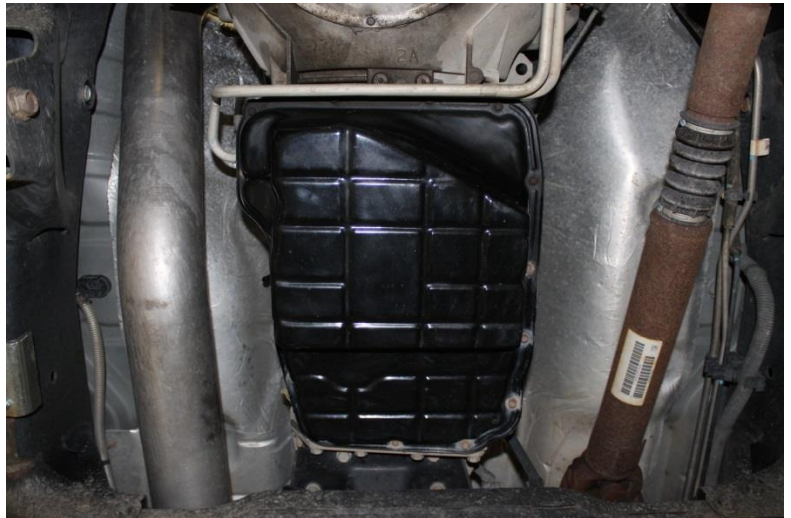
9. Tap pan with a mallet to break the silicone gasket seal. Allow fluid to drain. Remove last screw and drain remainder of fluid.

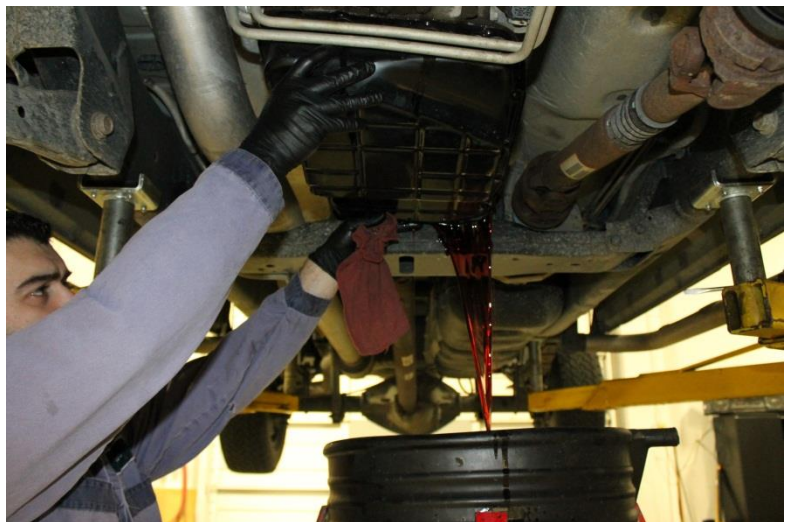
10. Remove transmission filter by removing the one T25 Torx screw.

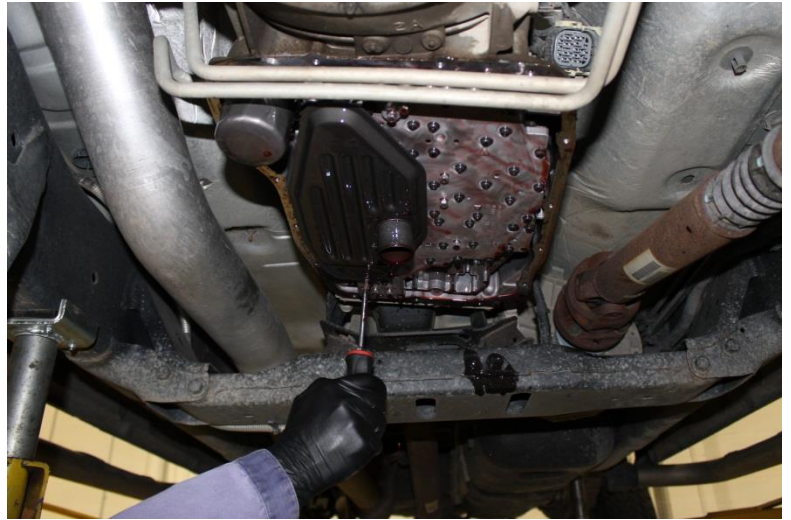
11. Remove the six 8mm bolts securing the valve body to the transmission. Drain valve body of fluid. To remove valve body from transmission, wiggle it while pulling downwards to work the electrical connector through the case.

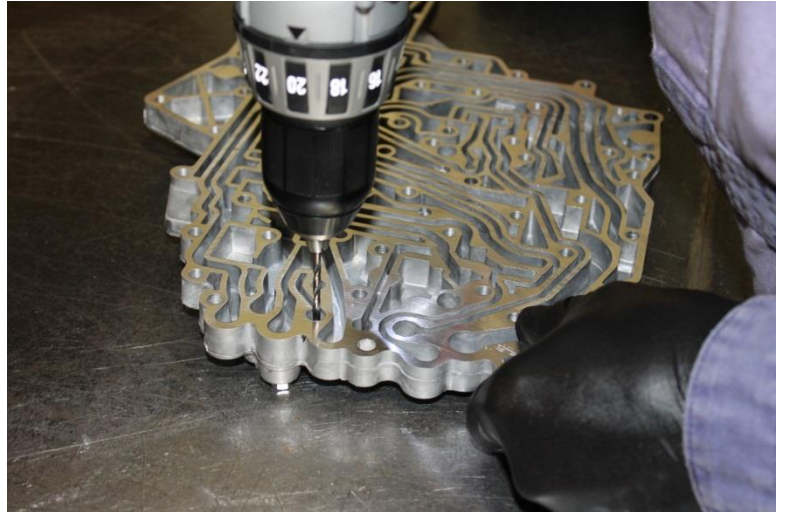
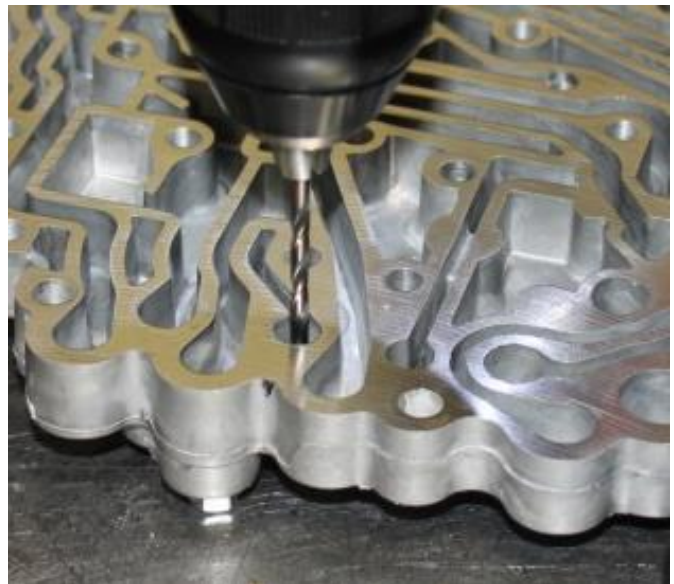
19. Drill hole with 1/8" drill bit.

20. Thoroughly remove any burrs and clean all shavings from the valve body. It is imperative that no contaminants are left as they may cause transmission damage.

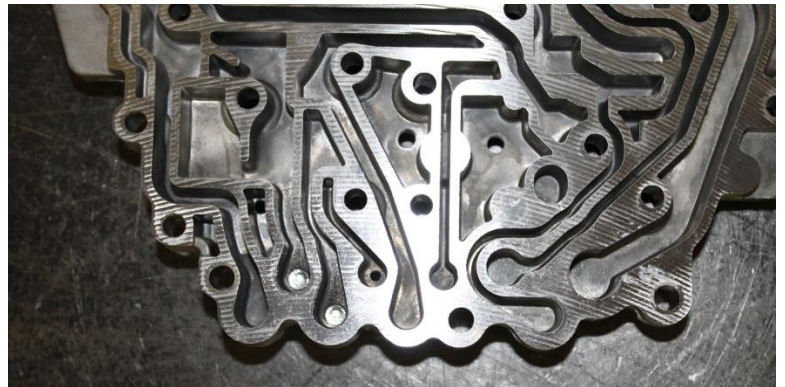
21. **IMPORTANT!** Ensure that all the check balls are in the locations shown.

If the electrical connector on the valve body is white make sure you have all seven check balls installed.

Discard any extra check balls.

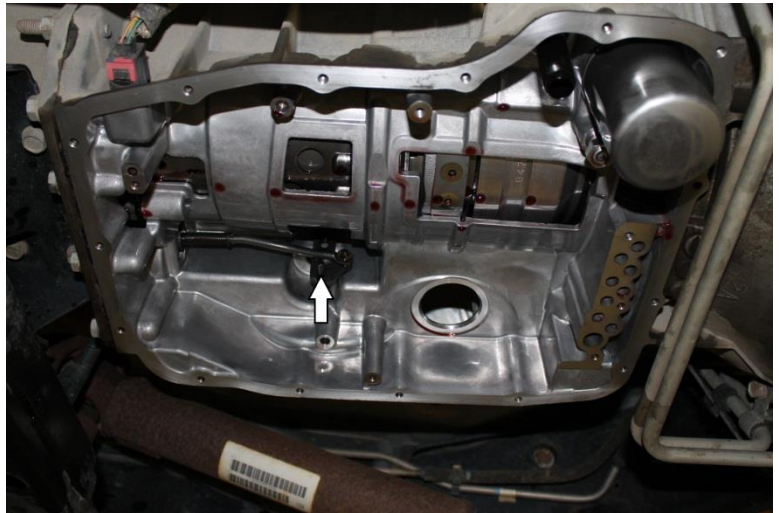
31. Torque the valve body attaching bolts to 105 in/lbs.

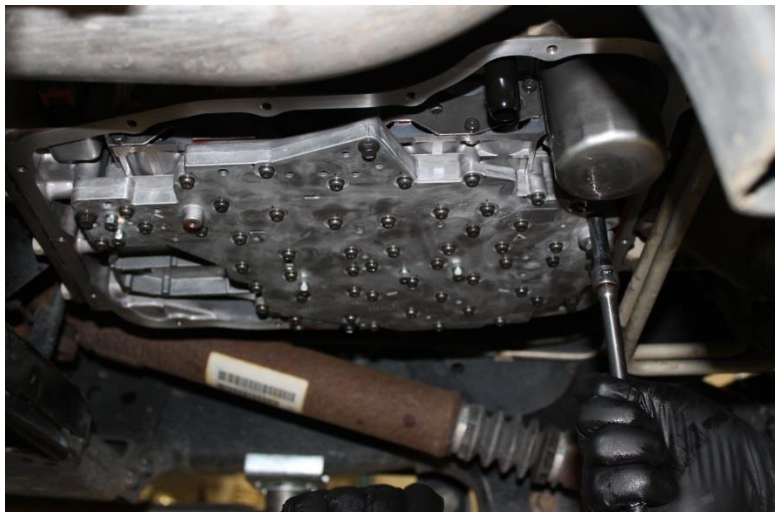
32. If desired, install new filter(s). Otherwise, reinstall the filter/pickup assembly. Torque to 50 in/lbs.

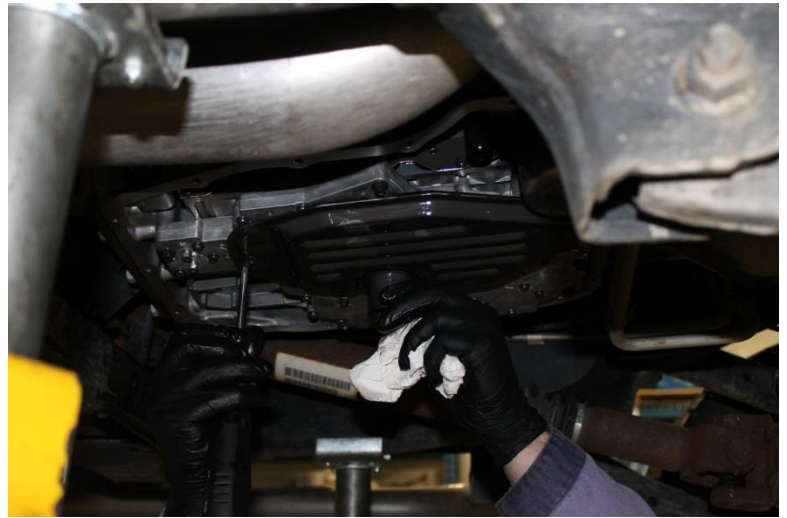
33. Place the supplied gasket on the transmission pan. Hold pan below transmission and install attaching screws. Torque the pan screws to 105 in/lbs.

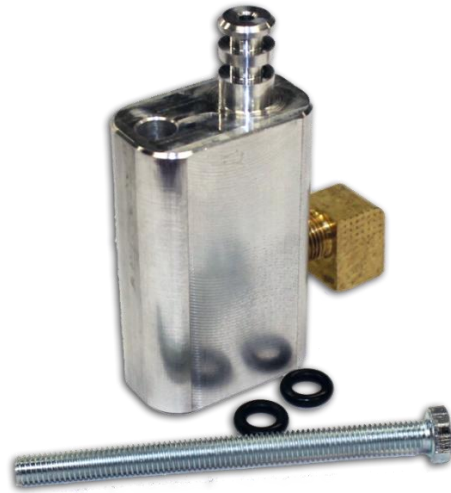
ADAPTER KIT BD# 1061529

Use this kit with a 300 psi gauge.

40. Note. If you would like to verify the increases in line pressure, use adapter kit (BD 1061529) in conjunction with a 300psi gauge. Pressures at wide open throttle should be between 240 – 260 PSI with a mechanical gauge.
