# Thermostat Bypass Kit

Transmission Cooler Line Thermostatic Valve Bypass Kit

**1061527**

**2019-2022 RAM Trucks (see fitment guide)**

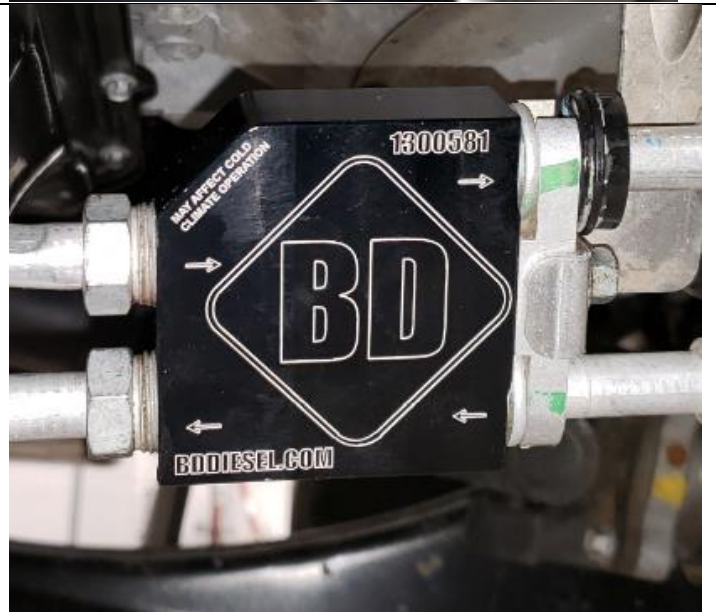
Reinstall both transmission cooler lines in to threaded end of the block, wiggle the lines and nut to start the threads.  
Tighten nuts 24 lb-ft.

Correct transmission fluid level and check for possible leakage.
