AAK461 – G-Body Front Lower Control Arms

Lower Control Arm Instructions (AAL461):

Upper Control Arm Instructions (AAL462):

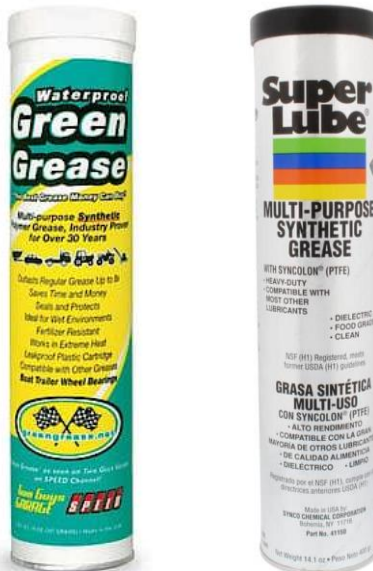
Attention: Polyurethane and Delrin bushings must be properly lubricated with a full synthetic grease only

A full synthetic grease must be used to lubricate the inner sleeve via the grease fitting, contact points such as the outside faces of the polyurethane bushing must also be greased. We recommend Green Grease/Super Lube full synthetic grease for best results.

Do not install bushings dry. Lack of proper lubrication may cause squeaking, binding, premature wear, reduced performance, or damage to the bushings and related components. Bushings should be inspected and re-greased as needed, especially in harsh driving conditions or high-use applications.
