## 3" Side Bar

### Part No. A0009S/B

**Fits: 2005-2018 Toyota Tacoma Access Cab**

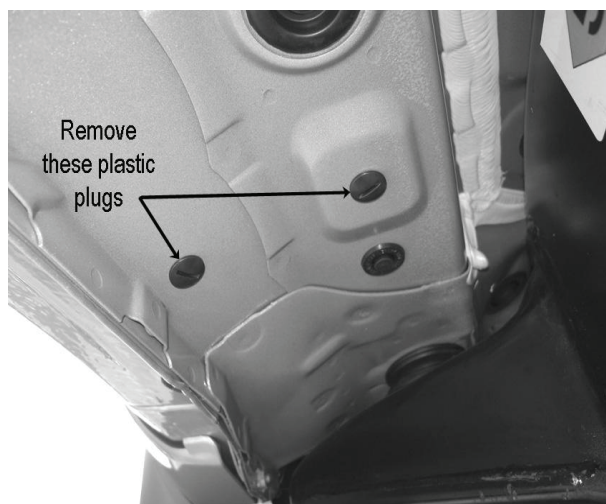
(Fig 1) Driver side front mounting location

- Starting on the driver side front of the vehicle, use a flat screw driver to remove the plastic plugs, **(Figure 1)**. Partially attach drivers side front Mounting Bracket to vehicle using the included (2) 8mm x 30mm Hex Bolts, (2) 8mm Lock Washers and (2) 8mm Flat Washers, **(Figure 2)**. Repeat this step for installing the driver's side rear Mounting Bracket, **(Figure 3)**
- Align the threaded inserts on the Side Bar with the slots on the Mounting Brackets. Attach Sidebar to Mounting Brackets with the included (4) 8mm x 30mm Hex Bolts, (4) 8mm Flat Washers and (4) 8mm Lock Washers, **(Figure 3)**. Do not tighten hardware at this time.
- Level and adjust the Sidebar properly and tighten all hardware.
- Repeat Steps 2-4 for installing passenger Sidebar.

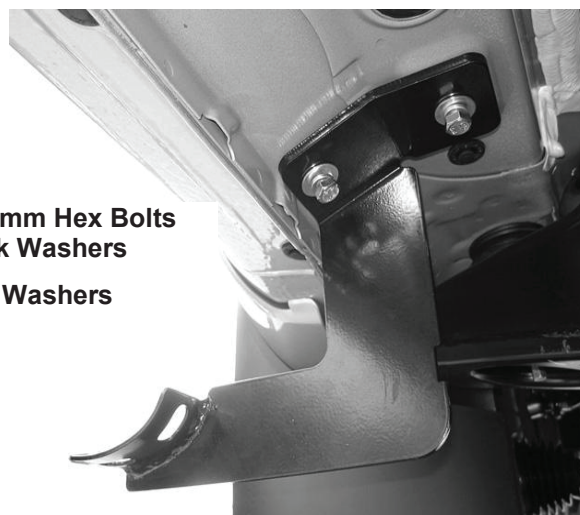
(Fig 2) Driver side front Bracket pictured

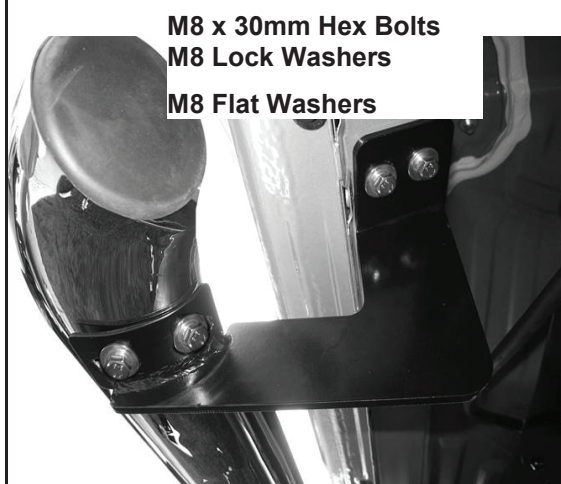
(Fig 3) Driver side rear Bracket pictured

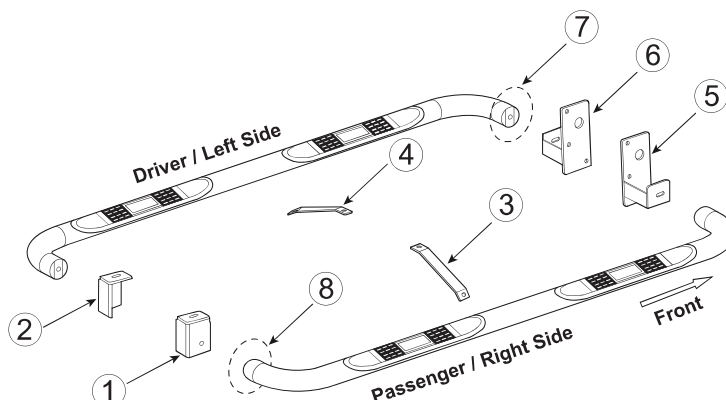
## PARTS IDENTIFICATION GUIDE

**Driver Side tube taped in "Red" Color. Passenger Side tube taped in "Blue" Color.**

| No. | Parts Identification |
| 1 | Passenger / Right 'Rear' Bracket marked "RR" |
| 2 | Driver / Left 'Rear' Bracket marked "RL" |
| 3 | Passenger / Right 'Center' Bracket marked "CR" |
| 4 | Driver / Left 'Center' Bracket marked "CL" |
| 5 | Passenger / Right 'Front' Bracket marked "FR" |
| 6 | Driver / Left 'Front' Bracket marked "FL" |
| 7 | 'Left' marked "L" |
| 8 | 'Right' marked "R" |
