## 4" Oval Straight Side Bar

Part No. 2940413051 /2940413053

Fits: 2005-Current NISSAN FRONTIER

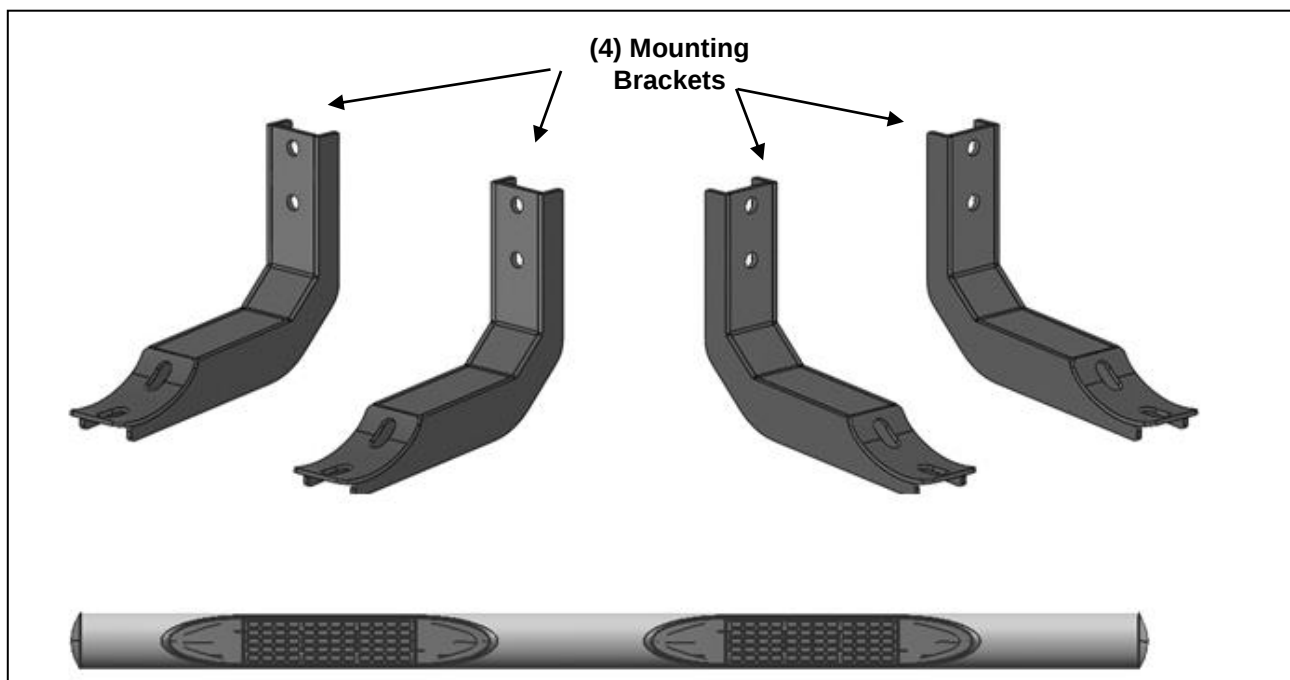
### PARTS LIST:

| Qty | Part Description | Qty | Part Description |
| 1 | Driver/Left Sidebar | 8 | 8mm Lock Washers |
| 1 | Passenger/Right Sidebar | 8 | 8mm x 24mm OD x 2mm Flat Washers |
| 4 | Mounting Brackets | 8 | 8mm Hex Nuts |
| 8 | 8mm x 25mm Combo Bolts | | |

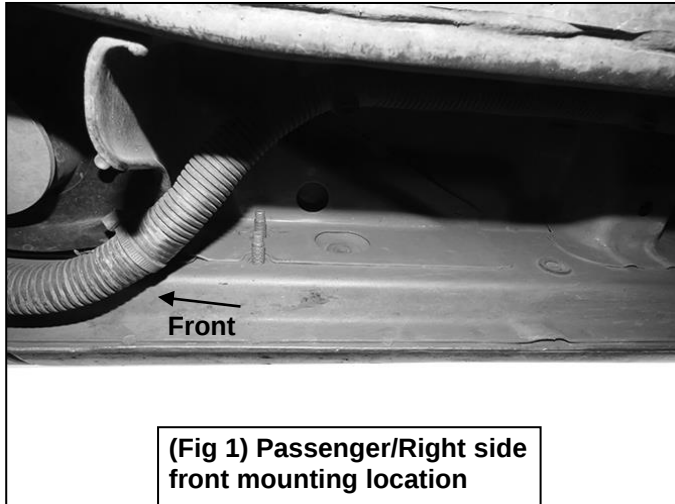
1. REMOVE CONTENTS FROM BOX. VERIFY ALL PARTS ARE PRESENT. READ INSTRUCTIONS CAREFULLY. CLEAN MOUNTING STUDS WITH WIRE BRUSH TO REMOVE PAINT AND DEBRIS.
2. Starting on the Passenger/Right side front of the vehicle, (**Figure 1**). Attach (1) Mounting Bracket to the front location with (2) 8mm Flat Washers and (2) 8mm Flange Nuts, (**Figure 2**). Do not tighten hardware.
3. Repeat **Step 2** to attach (1) Mounting Bracket to the Passenger/Right rear location, (**Figure 3**).

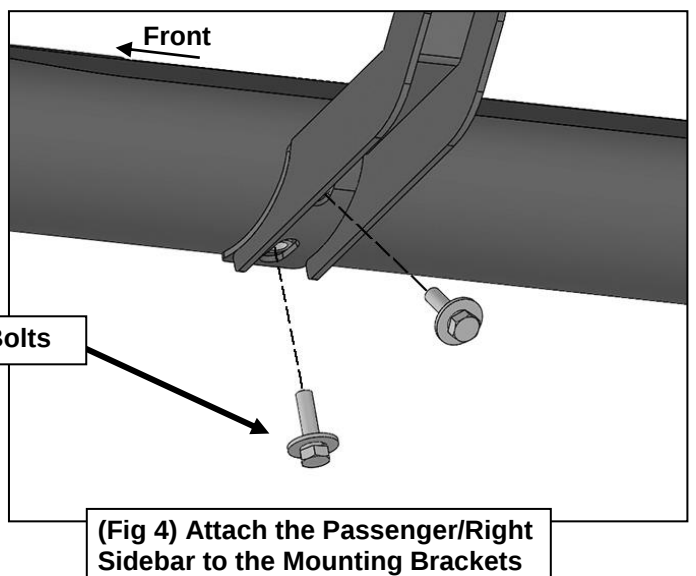
4. Select the Passenger/Right Sidebar. Carefully place Sidebar on the Mounting Brackets. **IMPORTANT:** Do not slide or rotate Sidebar on cradles, or damage to the finish may result. Attach Sidebar to the Mounting Brackets with (4) 8mm Combo Bolts, **(Figure 4)**. Do not tighten hardware.
5. Level and adjust the Sidebar and tighten all hardware.
6. Repeat **Steps 1—5** to attach the Driver/Left Sidebar.
7. Do periodic inspections to the installation to make sure that all hardware is secure and tight.

(2) 8mm Combo Bolts

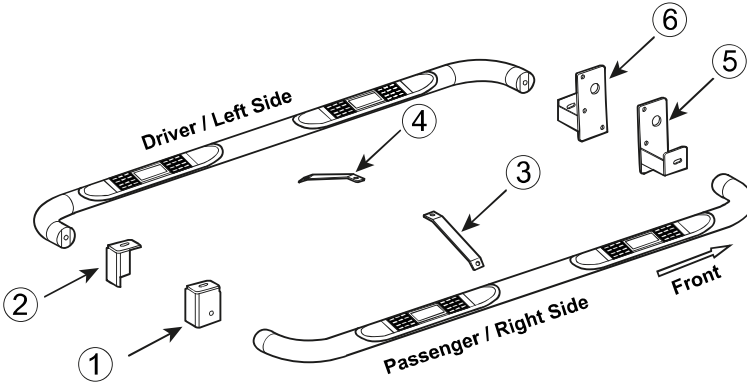
| No. | Parts Identification | |
|---|---|---|
| 1 | Passenger / Right 'Rear' Bracket marked "PR" | |
| 2 | Driver / Left 'Rear' Bracket marked "DR" | |
| 3 | Passenger / Right 'Center' Bracket marked "PC" | |
| 4 | Driver / Left 'Center' Bracket marked "DC" | |
| 5 | Passenger / Right 'Front' Bracket marked "PF" | |
| 6 | Driver / Left 'Front' Bracket marked "DF" | |

*In some cases Illustration images shown in Installation manual may not be the exactly same as per actual vehicle images ,also if Driver / Passenger side mounting brackets are very identical in the design, suggest referring Parts Identification guide to avoid fitment issue.*

*Side bar may be interchanged or mounting brackets are not installed at the correct position in the vehicle. Refer Parts identification guide.*
