# 4" Oval Side Bar

Part No. 2912133041/3

Chevrolet Colorado - Extended Cab  
ISUZU I-Series - Extended Cab  
GMC Canyon - Extended Cab

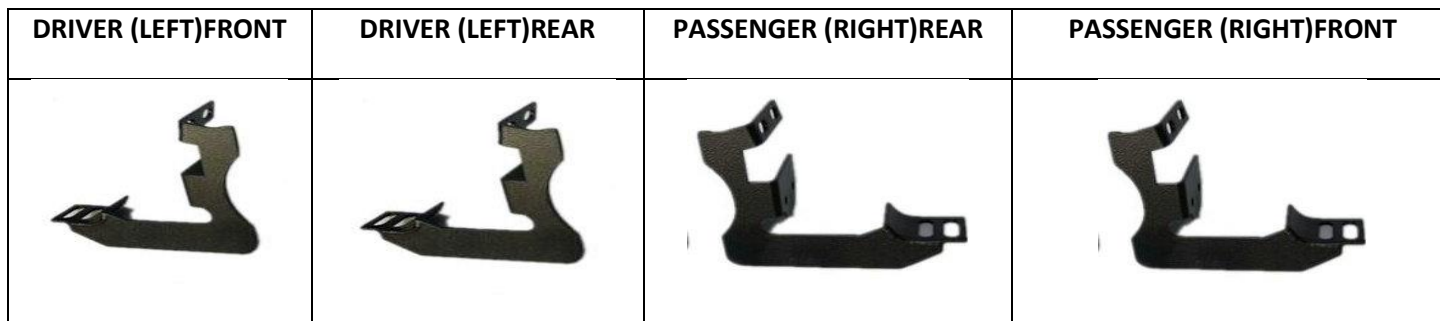
### PARTS LIST:

Qty	Part Description	Qty	Part Description
1 Set	Oval Step Bar	16	M8 Lock Washer
1 Set	Front Bracket	16	M8-1.25 Hex Nut
1 Set	Rear Bracket	4	M8-1.25 "U" Bolt
4	Backing plate	8	M10-1.5 x 30mm Button Head Bolt
8	M8-1.25 x 35mm Hex Head Bolt	8	M10 Flat Washer
24	M8 Flat Washer	8	M10 Lock Washer

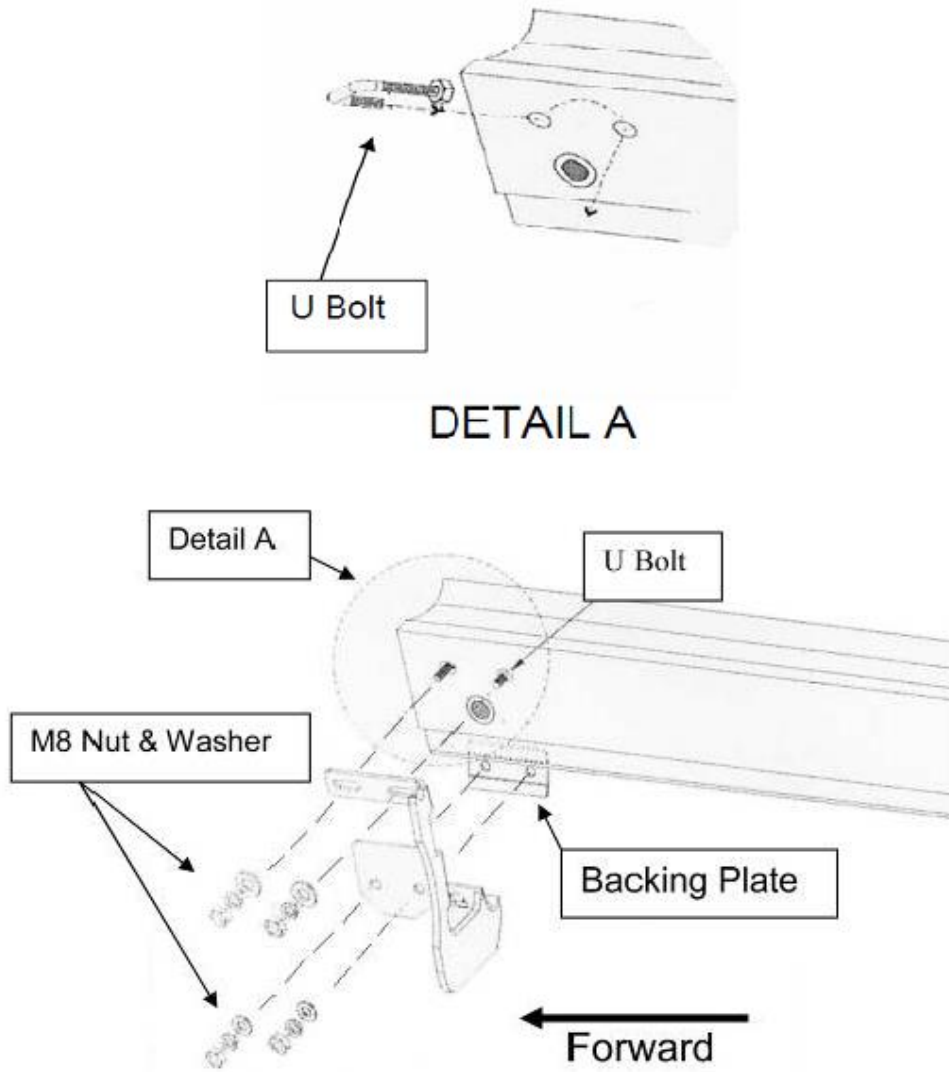
Figure 1. Passenger Side Front Bracket

1. Verify passenger and driver side bracket.
2. Locate the round holes on rocker panel for bracket installation. Insert M8 hex nut on the longer end of U-bolt. Insert U-bolt through the first hole and out through the second hole. Install M8 hex nut on shorter end of U-bolt after it comes through second hole in the rocker panel. This will help prevent the U-bolt from falling into the rocker panel. Remove the hex nut on the longer end of the U-bolt and position the top flange of the bracket onto the longer end of the U-bolt. Secure with M8 bolt set as shown. Leave loose. Remove the hex nut on the shorter end of the U-bolt. Position bracket and secure with M8 bolt set as shown. Repeat for all brackets. See Figure 1.

3. Secure the backing plates to the bracket using M8 bolt set as shown and leave loose. The backing plate will clamp the bracket and pinch weld together. See Figure 1. 2.

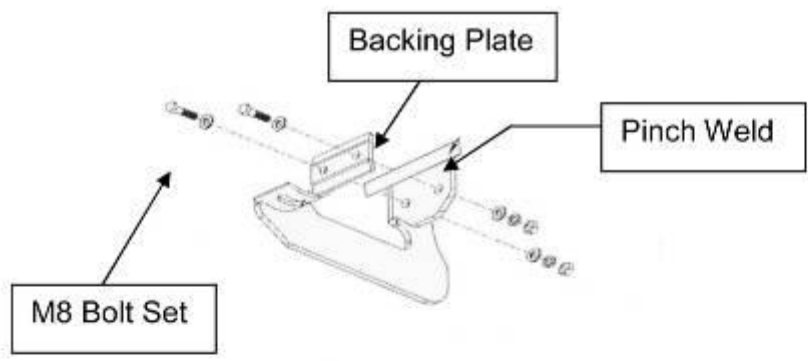
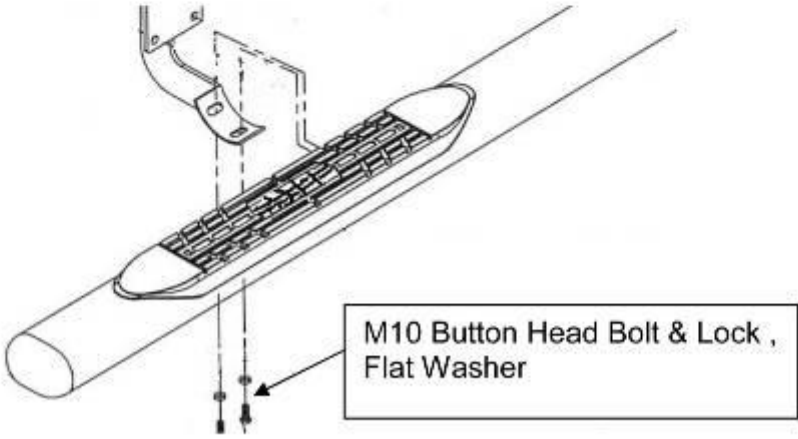
Figure 3.Installation View of Bracket & Bar

4. Place oval step bars on brackets. Each step bar is marked driver and passenger.
5. Assemble with M10 button head bolts and M10 washers. 2 bolts per bracket, 4 bolts per bar. See Figure 3.

DETAIL B

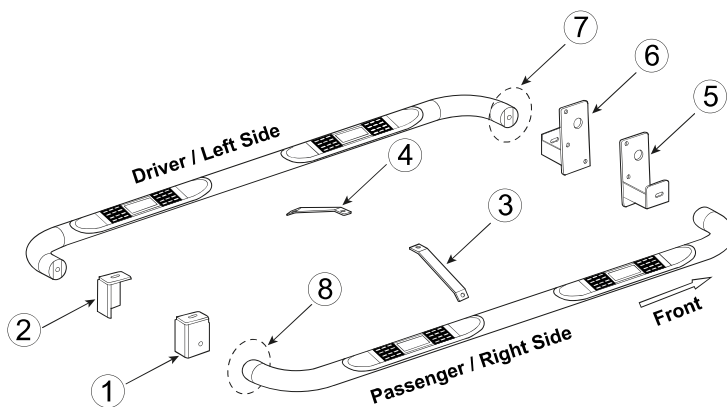
**RTS IDENTIFICATION GUIDE**

*Driver Side tube taped in "Red" Color. Passenger Side tube taped in "Blue" Color.*

No.	Parts Identification
1	Passenger / Right 'Rear' Bracket marked "RR"
2	Driver / Left 'Rear' Bracket marked "RL"
3	Passenger / Right 'Center' Bracket marked "CR"
4	Driver / Left 'Center' Bracket marked "CL"
5	Passenger / Right 'Front' Bracket marked "FR"
6	Driver / Left 'Front' Bracket marked "FL"
7	'Left' marked "L"
8	'Right' marked "R"
