# 4" Oval Nerf Bar

# Part No. 2930312041/3

Fits: 2004-2008 Ford F150-Regular Cab (excl. Heritage)

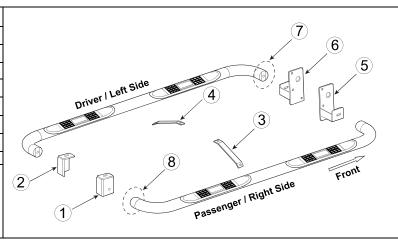
#### **PARTS IDENTIFICATION GUIDE**

Driver Side tube taped in "Red" Color. Passenger Side tube taped in "Blue" Color.

Passenger / Right 'Rear' Bracket marked "RR"  Driver / Left 'Rear' Bracket marked "RL"
	Oriver / Left 'Rear' Bracket marked "RL"
2 D	
3 P	Passenger / Right 'Center' Bracket marked "CR"
4 D	Oriver / Left 'Center' Bracket marked "CL"
5 P	Passenger / Right 'Front' Bracket marked " <b>FR</b> "
6 D	Oriver / Left 'Front' Bracket marked "FL"
7 'L	Left' marked "L"
8 'F	Right' marked " <b>R</b> "

In some cases Illustration images shown in Installation manual may not be the exactly same as per actual vehicle images ,also if Driver / Passenger side mounting brackets are very identical in the design, suggest referring Parts Identification guide to avoid fitment issue.

Side bar may be interchanged or mounting brackets are not installed at the correct position in the vehicle. Refer Parts identification guide.
