# 4" Oval Nerf Bar

## Part No. 2940408051/3

Fits: 2005 - 2016 Nissan Xterra

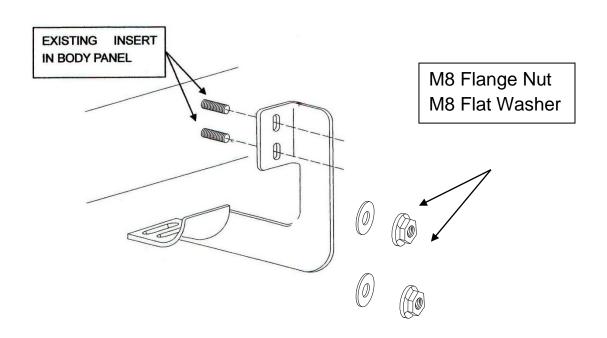
Figure 1. Driver Side - Front & Rear Bracket

- 1. Determine driver side brackets. All driver side brackets are identical with metal cup facing toward the rear of the vehicle (see Fig. 1).
- 2. Install driver side bracket closest to the front wheel first. Use one, M8 flat washer, M8 Flange Nut by attaching to underside of body panel. Hand tighten. Use existing factory hole in body panel for install (see Fig 1).
- 3. Attach remaining driver side brackets to underside body panel by using 2 M8 Flange Nut, M8 flat washers per bracket. Hand tightens. Use existing factory holes in body panel (see Fig. 1).
- 4. Place driver side step bar on brackets. Each step bar is marked driver and passenger.
- 5. Assemble with M10 button head bolts and M10 lock washers. 2 bolts per bracket, 6 bolts per bar (see Fig 2). Hand tightens.
- Repeat installation for passenger side.

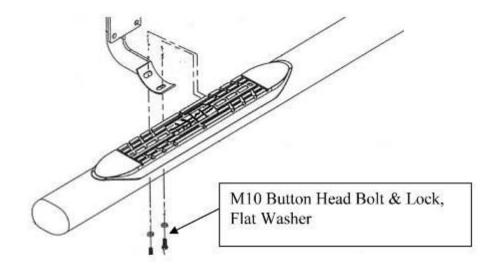
Figure 2. Installation View of Bracket & Bar

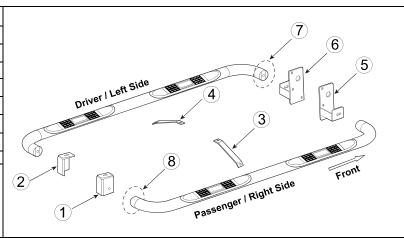
#### PARTS IDENTIFICATION GUIDE

Driver Side tube taped in "Red" Color. Passenger Side tube taped in "Blue" Color.

No.	Parts Identification	
1	Passenger / Right 'Rear' Bracket marked "RR"	
2	Driver / Left 'Rear' Bracket marked "RL"	
3	Passenger / Right 'Center' Bracket marked "CR"	
4	Driver / Left 'Center' Bracket marked "CL"	
5	Passenger / Right 'Front' Bracket marked "FR"	
6	Driver / Left 'Front' Bracket marked "FL"	
7	'Left' marked "L"	
8	'Right' marked "R"
