## 4" Oval Nerf Bar

### Part No. 2982826011/3

Fits: 2001-2006

Honda MDX/Pilot

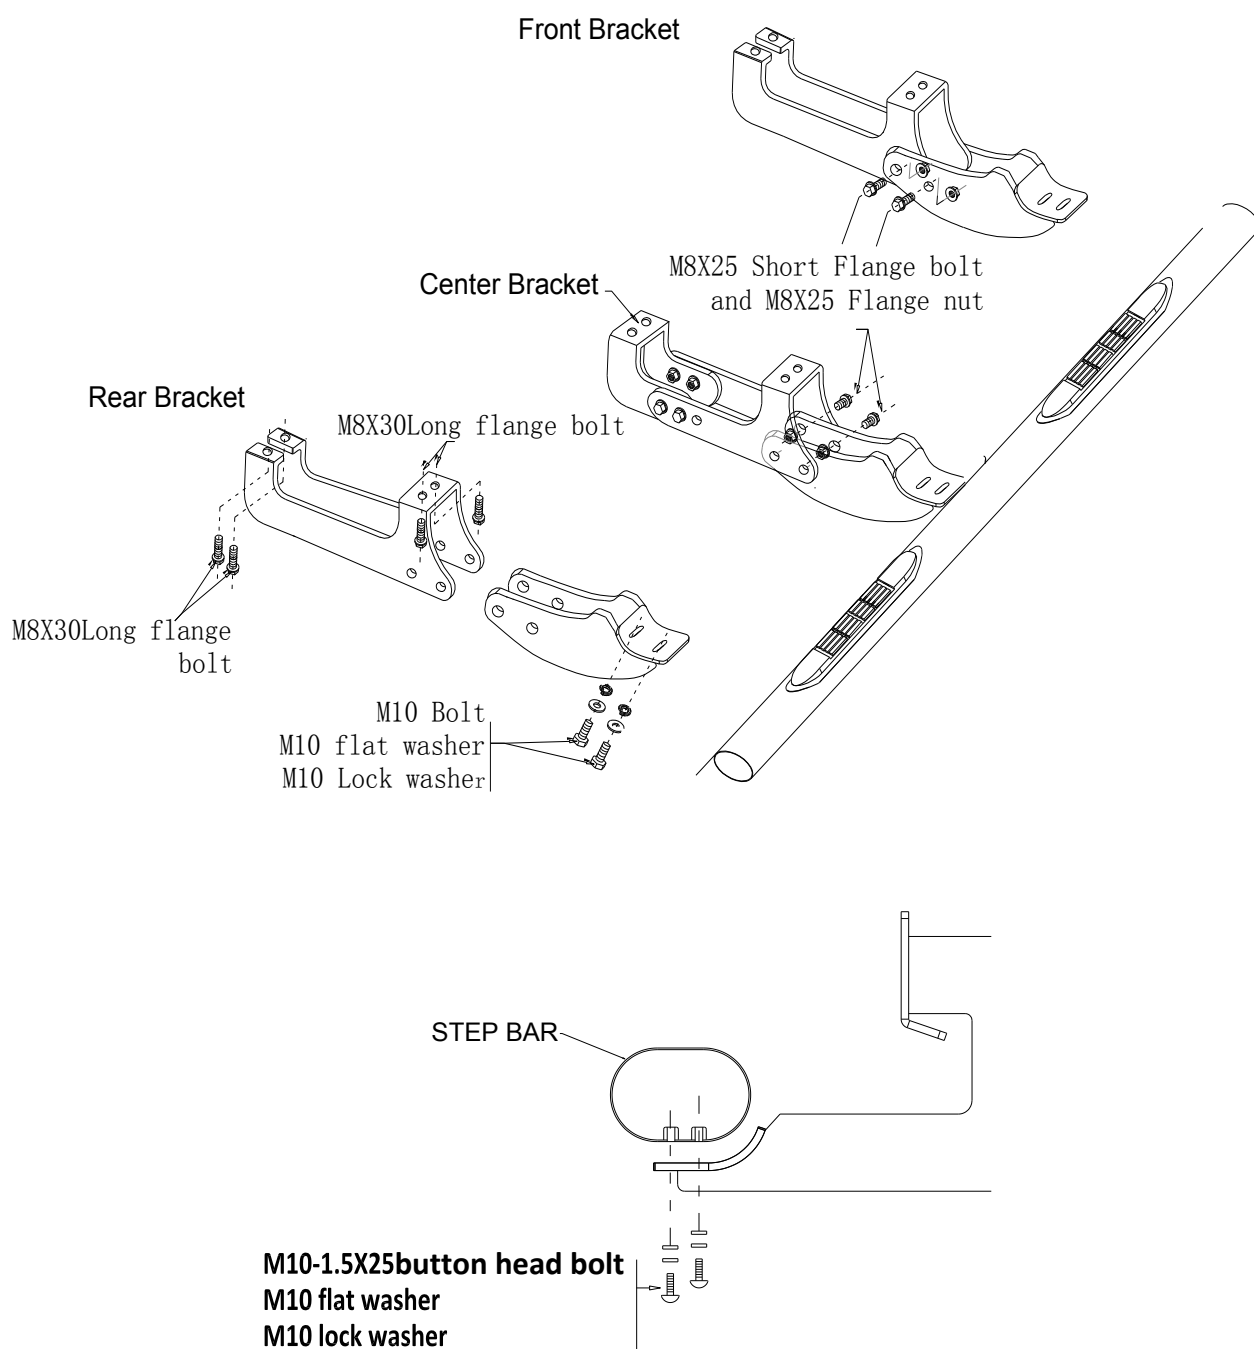
1. Please prepare the tools for installation, follow as :14-17 wrench.
2. Locate the Front bracket, Center bracket and the Rear bracket with the M8-1.25 x 30mm long flange bolt on the girder of the car, and then tighten them.
3. Connect the Front bracket (2 pieces per side) using the M8-1.25 x 25mm short flange bolt ,and then tighten it.
4. Connect the Center bracket (3 pieces per side) using the M8-1.25 x 25mm short flange bolt, and then tighten it.
5. Connect the Rear bracket (2 pieces per side) using the M8-1.25 x 25mm short flange bolt, and then tighten it.
6. Attach the bracket to the Side bar using the Button head bolt, and then tighten it.
7. Test and make sure the Side Bar with all hardware are steadily fixed.

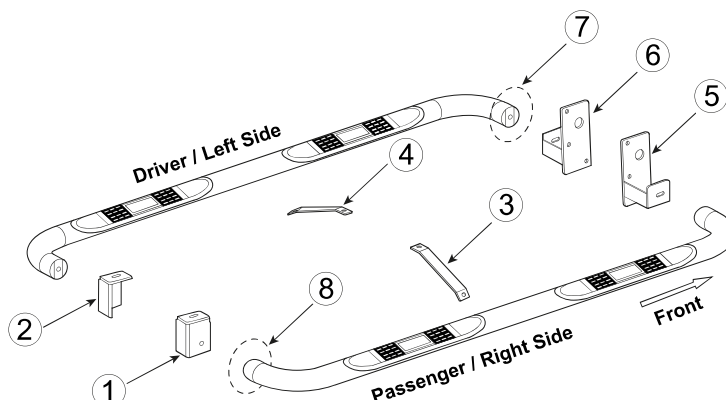
## PARTS IDENTIFICATION GUIDE

**Driver Side tube taped in "Red" Color. Passenger Side tube taped in "Blue" Color.**

No.	Parts Identification
1	Passenger / Right 'Rear' Bracket marked "RR"
2	Driver / Left 'Rear' Bracket marked "RL"
3	Passenger / Right 'Center' Bracket marked "CR"
4	Driver / Left 'Center' Bracket marked "CL"
5	Passenger / Right 'Front' Bracket marked "FR"
6	Driver / Left 'Front' Bracket marked "FL"
7	'Left' marked "L"
8	'Right' marked "R"

In some cases Illustration images shown in Installation manual may not be the exactly same as per actual vehicle images ,also if Driver / Passenger side mounting brackets are very identical in the design, suggest referring Parts Identification guide to avoid fitment issue.

Side bar may be interchanged or mounting brackets are not installed at the correct position in the vehicle. Refer Parts identification guide.
