Full Length Hoop Step

Part No. A3333

Fits: **2015 - Current** **Chevrolet Silverado 2500/3500 Single Wheel Crew Cab 8' Bed**
2015 - Current **GMC Sierra 2500/3500 Single Wheel Crew Cab 8' Bed**

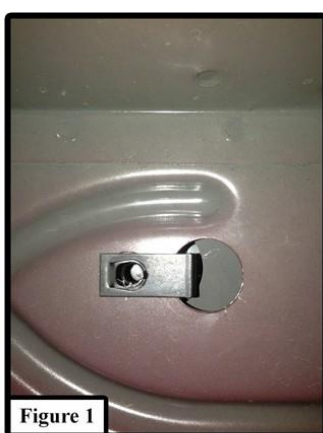
Figure 1

Step 3. If the vehicle requires use of clips, install those now. This requires the removal of a plastic body plug. Use a screwdriver to remove each plug, and install the clips as shown in figure 1.

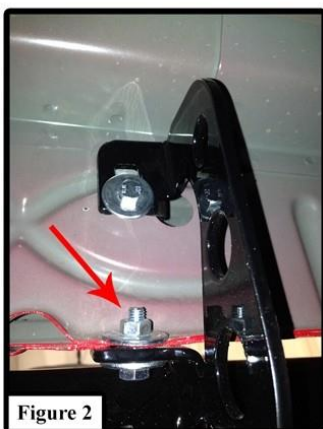
Figure 2

Step 4. Align the steps with the mounting holes. Beginning at the front, use (1) M8-1.25 bolt and (1) fender washer for each mounting location and thread the bolts into the mounting holes. NOTE: Some vehicles require the use of an additional nut and washer for the lower portion of the mounting bracket as shown in figure 2. Nuts and washers are supplied.
