5" Oval Nerf Sidebar

Part No. A7087S /B

FitS: 2019-Current SILVERADO/SIERRA 1500 (Incl. Diesel models with DEF tanks) (Rocker Panel Mount) / 2020-Current SILVERADO/SIERRA 2500/3500 CREW CAB (Incl. Diesel models with DEF tanks)

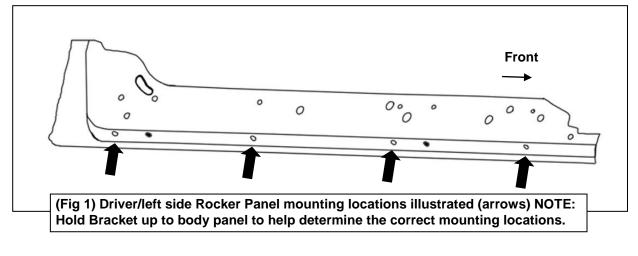
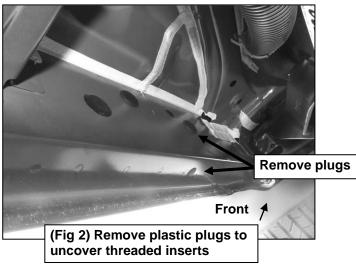
- Start the installation under the driver side of the vehicle. Locate the 6 plugs along the bottom edge of the body. Mounting Brackets will bolt to the 1st, 3rd, 4th and 6th threaded mounting holes, (Figures 1—6). Remove the plastic plugs from each mounting location. Directly above each threaded insert is a top mounting location on the side of the body panel. Hold a Bracket up in place to help determine the mounting holes to use along the body. NOTE: Thread an 8mm Hex Bolt into the threaded inserts to clear paint as required.

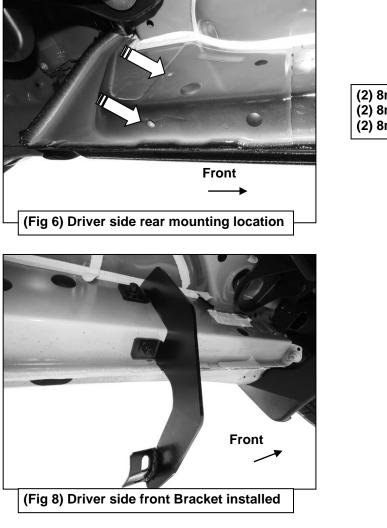
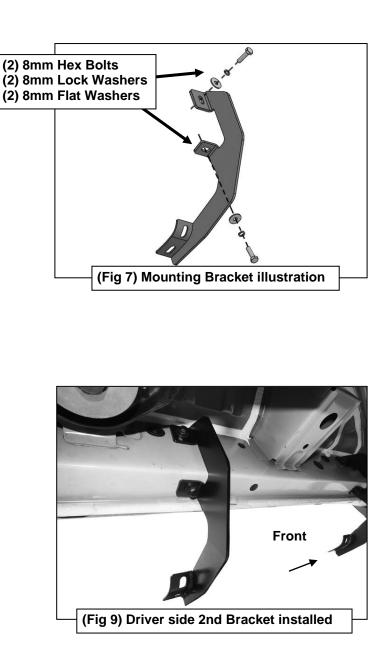
Driver/left side Installation Pictured

- Select (1) Mounting Bracket. Starting at the front of the driver/left side, bolt the Mounting Bracket to the factory threaded holes with (2) 8mm Hex Bolts, (2) 8mm Lock Washers and (2) 8mm Flat Washers, (Figures 7 & 8). Do not tighten hardware at this time.

- 3. Repeat Steps 1 & 2 to install (3) Mounting Brackets on the remaining driver/left side mounting locations along the body panel, (Figures 9—11).
- 4. Select the Driver/left Sidebar. Use the illustration above to help determine the correct Sidebar. Place the Sidebar on top of the Brackets. IMPORTANT: Do not slide, (front to back or rotate), the Sidebar on the Brackets or damage to the finish may result.

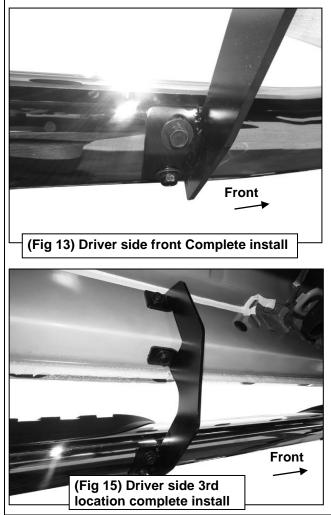
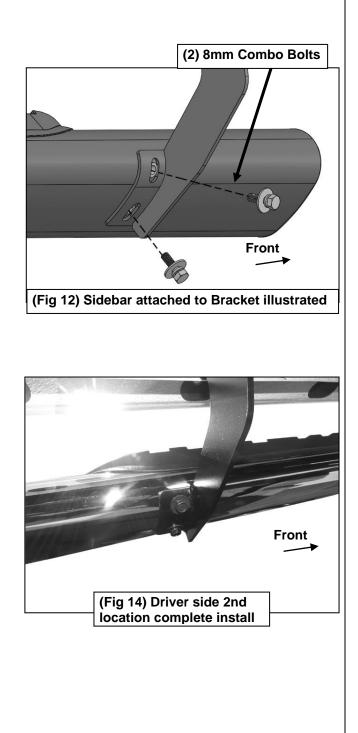
Driver/left side Installation Pictured

- 5. Attach the Sidebar to the Brackets with (8) 8mm Combo Bolts, (Figures 12-15).
- 6. Level and adjust the Sidebar and fully tighten all hardware.
- 7. Repeat **Steps 1—6** to install the Passenger/right Sidebar.
