A4 ALUMINIUM STEP BAR

Part No. AL4005B

Fits: 2019-2020 1500 CHEVY SILVERADO/GMC SIERRA DOUBLE CAB & 2020 SILVERADO/SIERRA 2500/3500 DOUBLE CAB

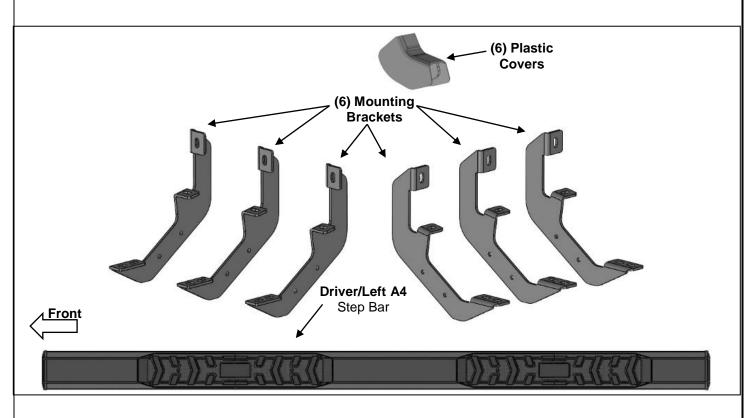
| PARTS LIST: | | | |

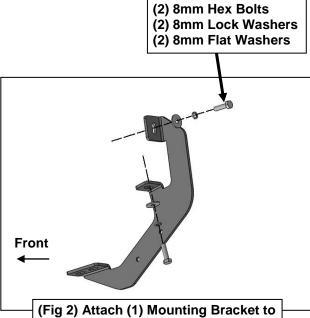
(Fig 2) Attach (1) Mounting Bracket to the Passenger/Right front location

- 2. Select (1) Mounting Bracket. Attach the Mounting Bracket to the factory threaded holes with (2) 8mm Hex Bolts, (2) 8mm Lock Washers and (2) 8mm Flat Washers, (Figure 2). Do not tighten hardware.

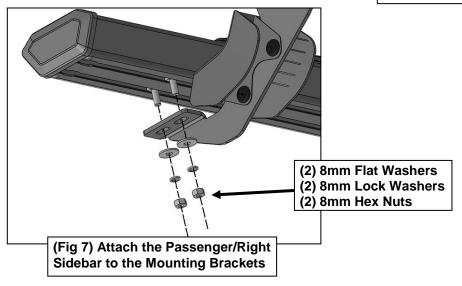
(Fig 6) Insert (6) T-Bolts into the channels in the bottom of the Sidebar, (3) per channel

- 5. Select the Passenger/Right A4 Step Bar. Insert (6) T-Bolts into the channels in the bottom of the Sidebar, (3) per channel, (Figure 6). Attach the Sidebar to the Mounting Brackets with (6) 8mm Flat Washers, (6) 8mm Lock Washers and (6) 8mm Hex Nuts, (Figure 7).
