GFB VTA

Installation Instructions

Part # T9468

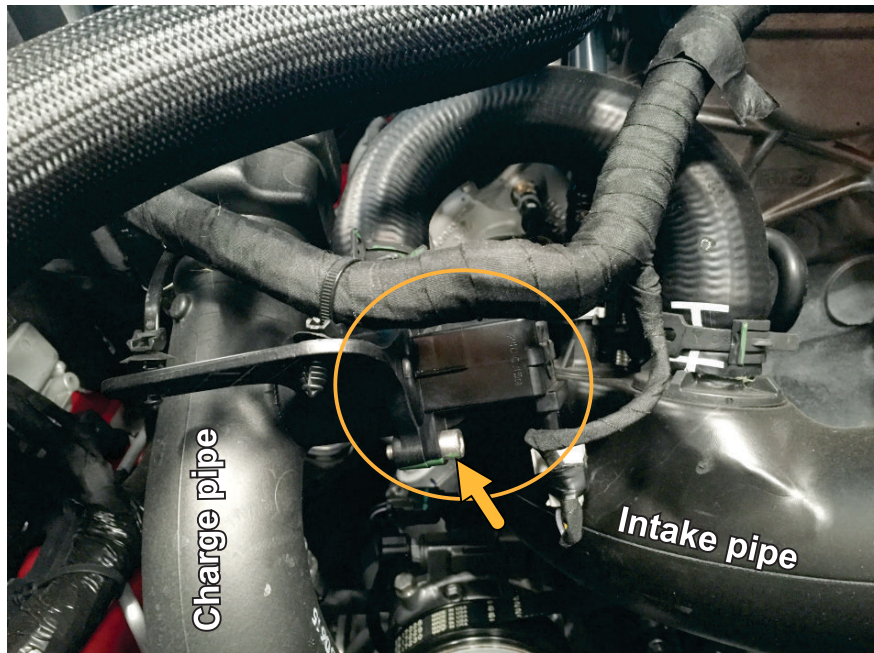
The factory diverter valve on the Mustang is located on the side of the charge pipe near the intake pipe.

Using a 5mm hex driver/key, undo the 3 screws (→) holding the diverter, unclip the electrical connector, and remove the diverter from the car.

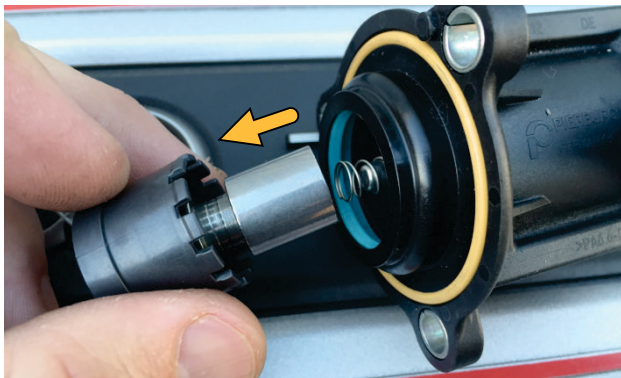
Pull the piston from the factory diverter valve solenoid and remove the spring.

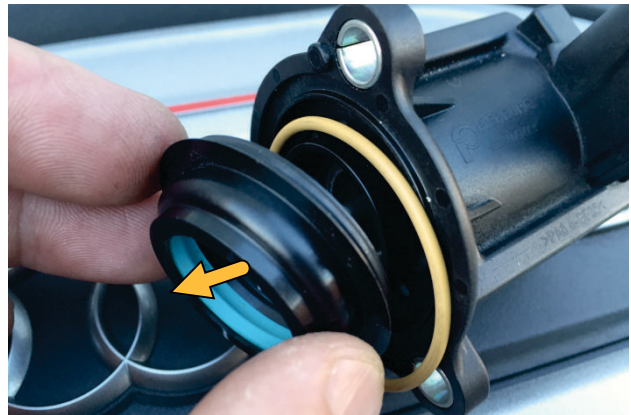
Next, remove the plastic piston shroud. This should be able to be removed by hand, but if it does need to be levered out take care not to damage any of the plastic pieces.

The factory yellow o-ring is required for the VTA installation, but the piston, shroud, and spring are not, so store these in a safe place.

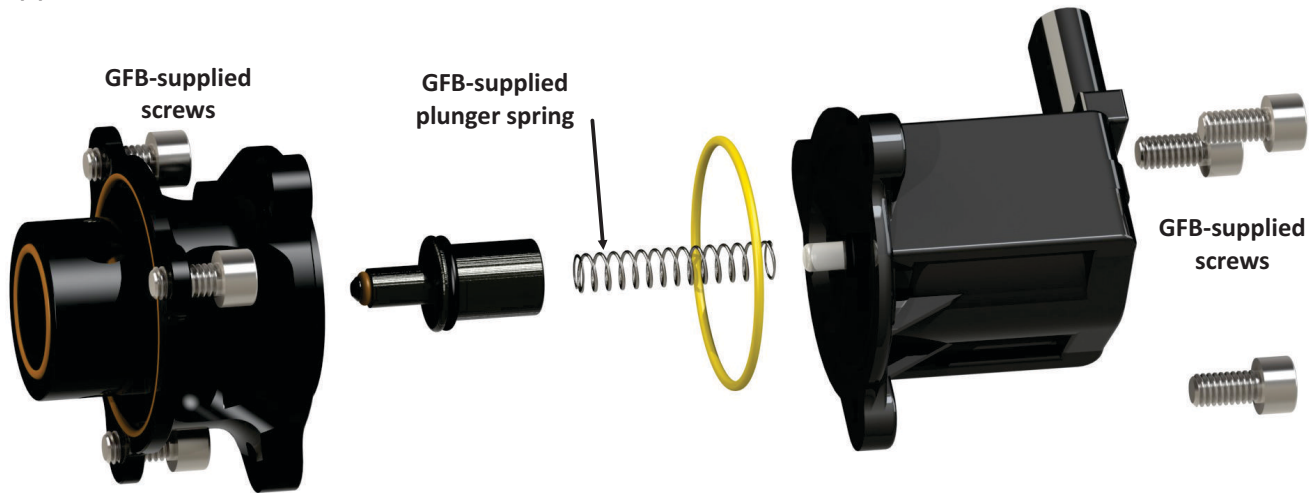
- Insert the GFB supplied spring (**DO NOT re-use the factory spring**) and plunger into the solenoid, and check that it slides freely. Now fit the VTA body and factory yellow o-ring onto the plunger/spring/solenoid assembly as shown below, securing the solenoid to the VTA with 3 of the 6 supplied screws:

Assemble the supplied spring and plunger into the solenoid, then attach the VTA body to the solenoid with 3 of the supplied screws, as shown below.

- Install the VTA/solenoid assembly onto the diverter valve mount using the three remaining supplied screws. Because of the asymmetric bolt holes, the assembly can only be installed in one orientation.
- Clip the electrical connector back on, and replace any parts that have been removed for access during installation.
