Part number SES1572TT

2016-2021 Honda Civic

10th Gen. 1.5L turbo 4cyl.

1- 4 piece cat back dual exhaust

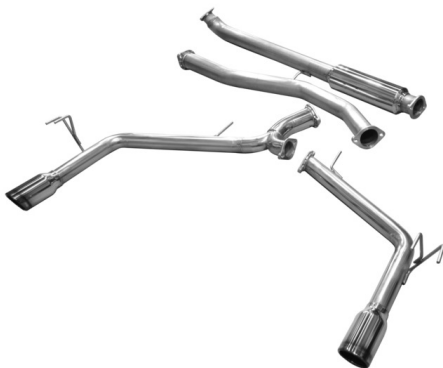
Figure 2

Complete kit:

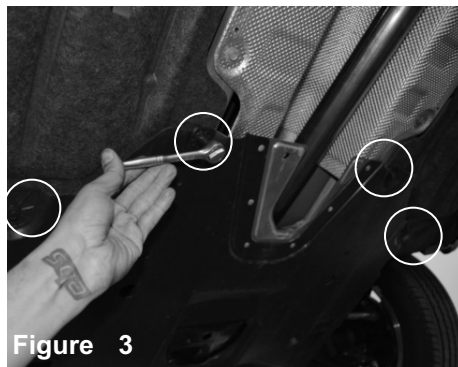
Figure 3

Loosen the screws holding in the factory engine cover. This will allow to loosen screws on pipe.

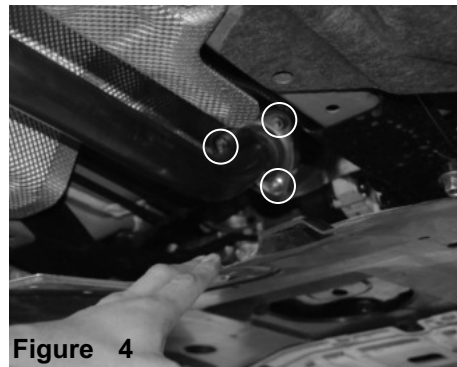
Figure 4

Loosen the 3 nuts holding in the pipe using 14 mm socket with wrench. Save these 3 nuts for later install.

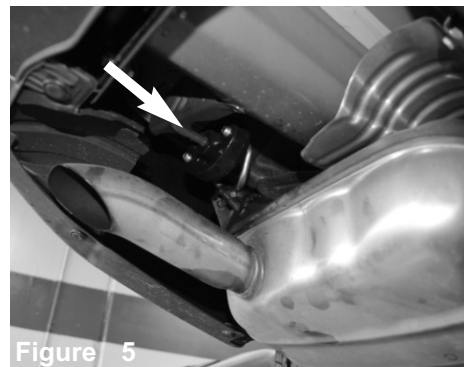
Figure 5

With lubrication, remove all the exhaust hangers from the rubber isolation mounts.

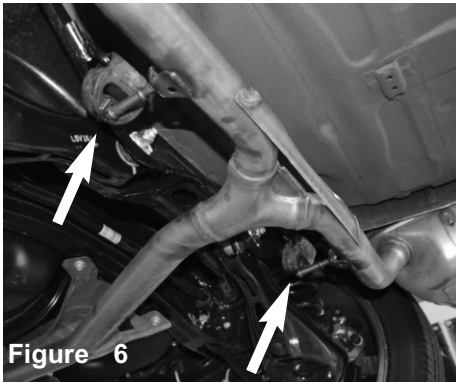
Figure 6

Continue to remove all hangars from the exhaust system.

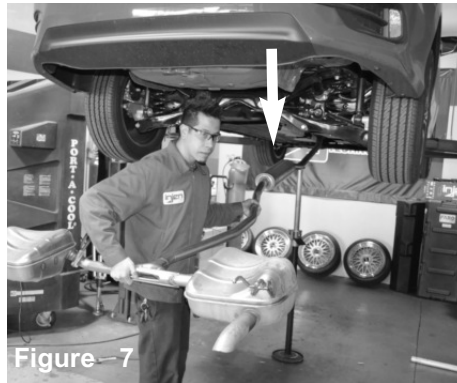
Figure 7

Carefully position and slide back and remove the exhaust out of the vehicle.

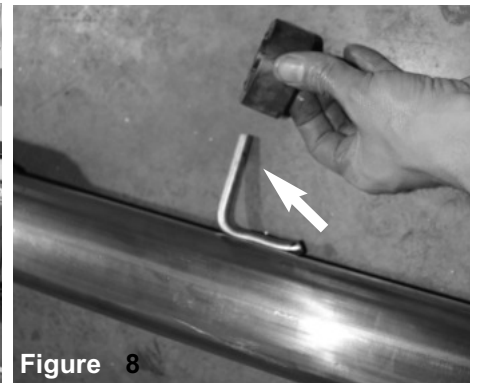
Figure 8

Remove the isolation mount from the exhaust closest to the 3 hole flange. Re-install to the new engine exhaust for easier installation.

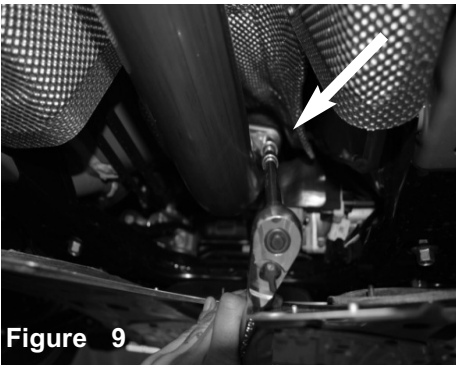
Figure 9

With provided 3 hole gasket, Install the front pipe to the 3 hole flange. Secure using original nuts from step 4.

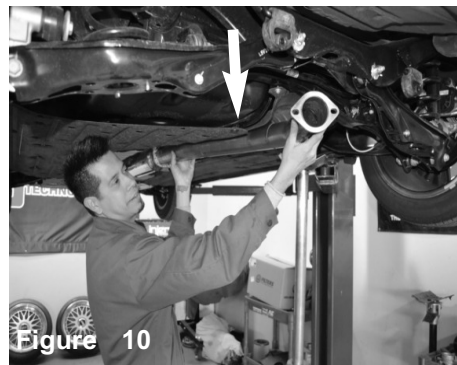
Figure 10

Now install the mid-pipe to the exhaust. Secure using provided 3" gasket and bolts with nuts.

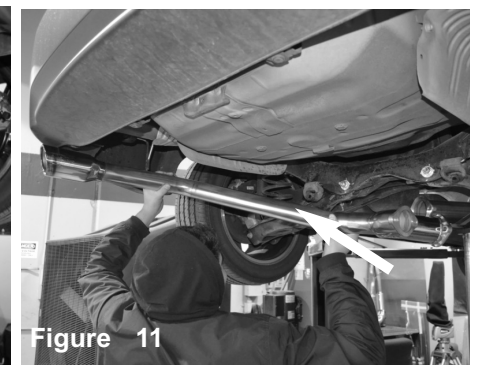
Figure 11

Install the rear sections, passenger side and driver side. Secure using provided M10 bolts and nuts with correct gasket. Do not tighten.

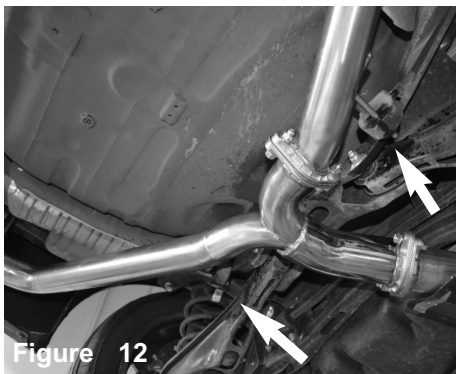
Figure 12

Position all the hangars to to the isolation mounts. Position and adjust fitment. Do not tighten.

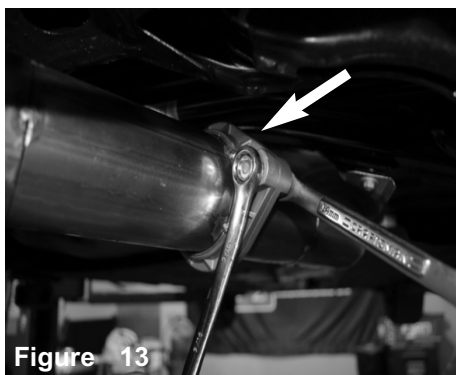
Figure 13

Position for best fit and clearance. Once the exhaust is in correct position, Secure and tighten.

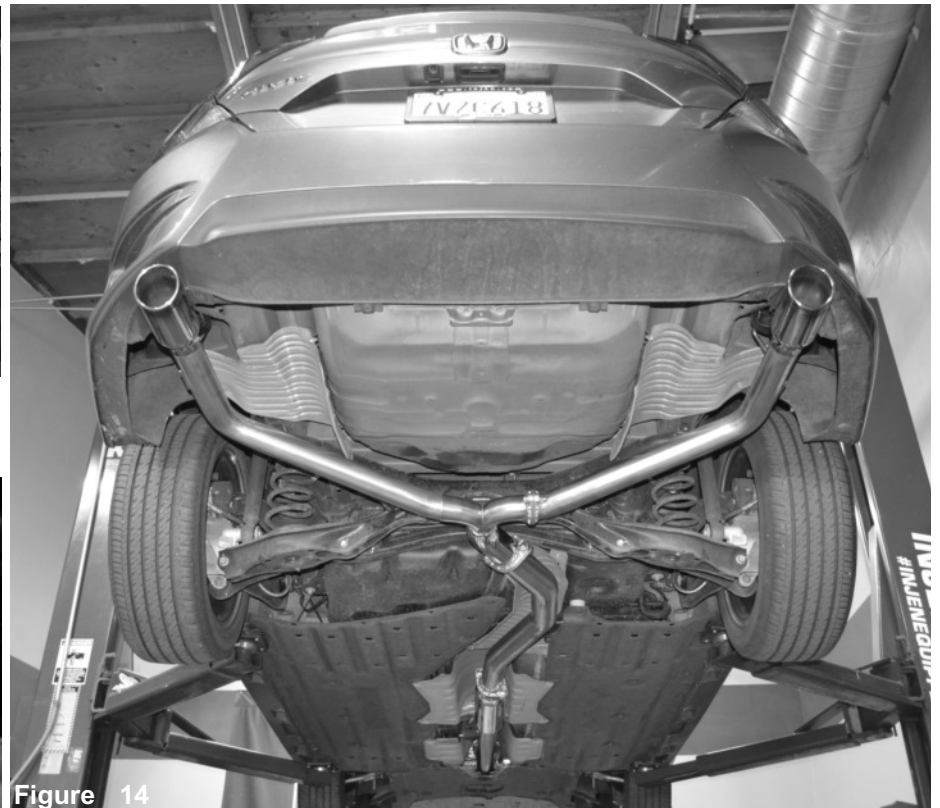
Figure 14

Congratulations! You have just completed the installation of this exhaust system. Verify and adjust the rear section of the exhaust, make sure muffler and tip do not touch any plastics or it can melt. Periodically, check the alignment of the exhaust, normal wear and tear can cause nuts and bolts to come loose. **Note: Check clearance and adjust if needed! Failure to check the alignment and adjust the exhaust can cause damage that will void the warranty. Injen Technology is not responsible for any damages caused by/from improper installation.**
