Part number SES2300RS
2020-23 Toyota Supra
MK5 A90
3.0L turbo 6cyl.

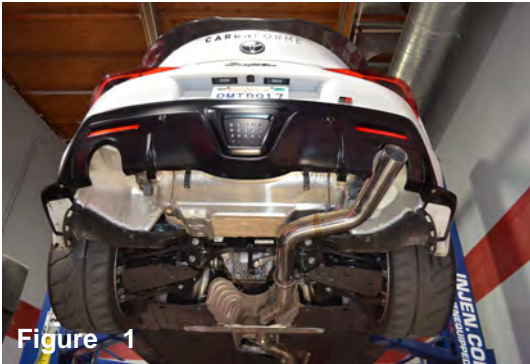
Figure 1

- 1- 3 piece cat back single exit exhaust
- 1- 3.25 Torsion Clamp 86mm (#17204)
- 2- 3.5" V band clamps (#17206-C)
- 1- Black zip tie (#8014)

Complete kit:
