**A4 ALUMINIUM  
STEP BAR**  
**Part No. AL4010B**

**Fits: 2019-2020 DODGE RAM 1500 CREW CAB**

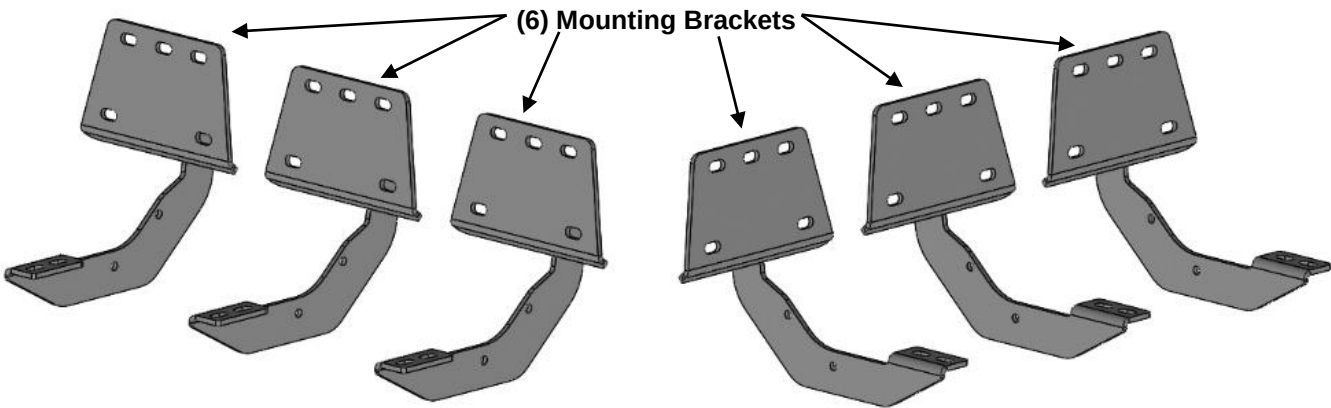
**(6) Plastic Covers**

**(6) Mounting Brackets**

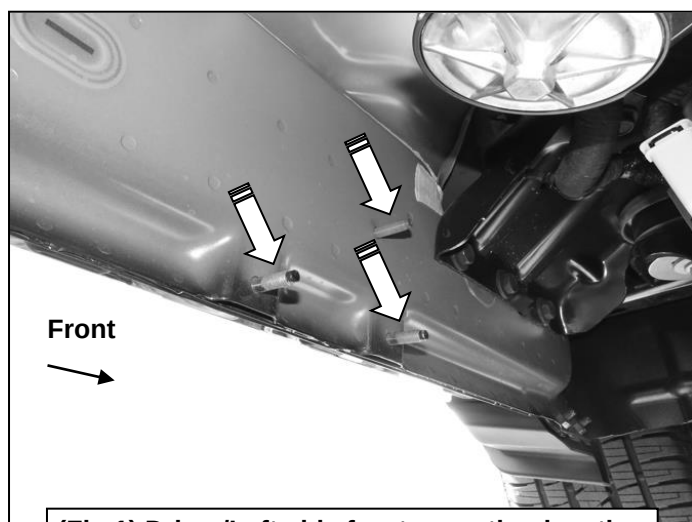
**(Fig 1) Driver/Left side front mounting location**

1. Start the installation under the Driver/Left side of the vehicle. Locate the front (3) factory studs along the inner side of the body panel, **(Figure 1)**. **NOTE:** Clean threads on the studs first before installing Brackets to remove paint buildup.

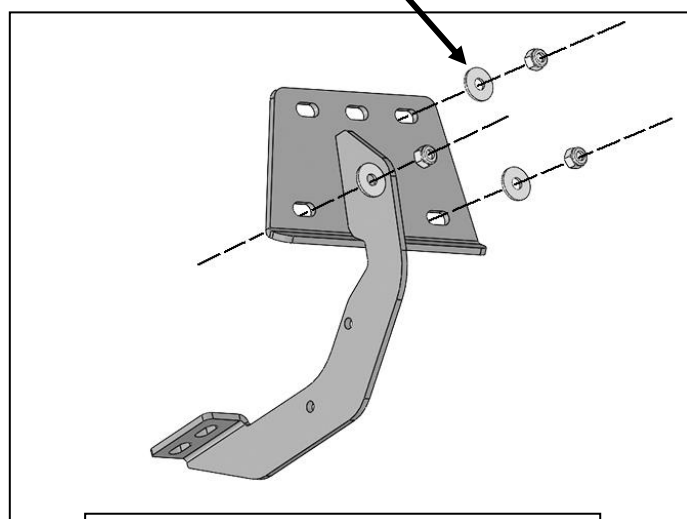
**(3) 8mm Flat Washers  
(3) 8mm Nylon Lock Nuts**

**(Fig 2) Attach Bracket to the (3) studs**

2. Select (1) Driver/Left Mounting Bracket. Attach the Mounting Bracket to the (3) factory studs with (3) 8mm Flat Washers and (3) 8mm Nylon Lock Nuts, **(Figure 2)**. Leave brackets loose at this time.

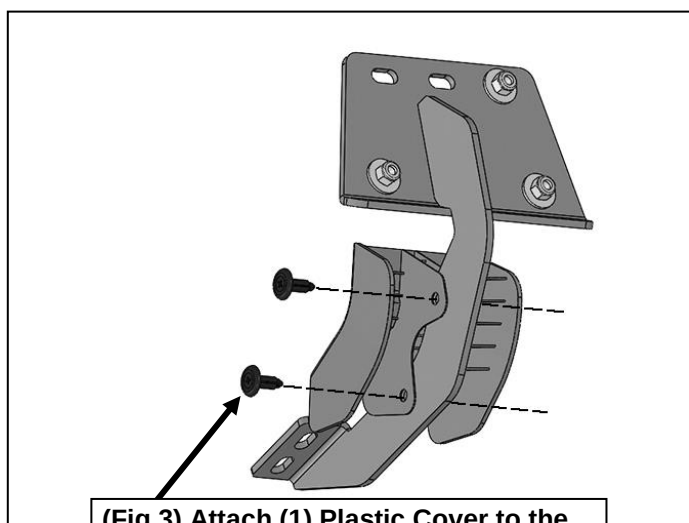
**(Fig 3) Attach (1) Plastic Cover to the Mounting Bracket with (2) Plastic Clips**

3. Select (1) Plastic Cover. Attach the Cover to the Mounting Bracket with (2) Plastic Clips, **(Figure 3)**.
4. Repeat **Steps 1—3** to attach (2) Mounting Brackets to the center and rear mounting locations along the body panel, **(Figures 4 & 5)**.

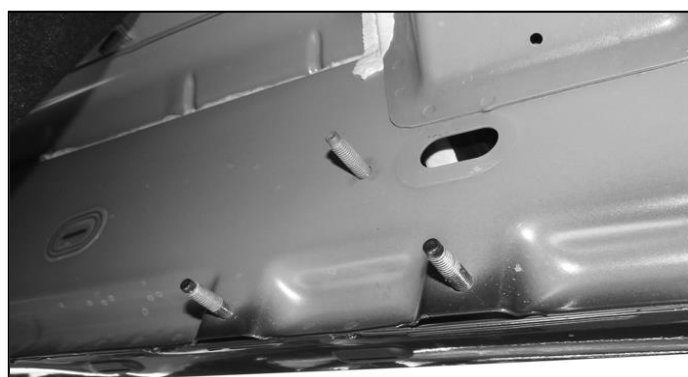
**(Fig 4) Attach (1) Mounting Bracket to the front mounting location**

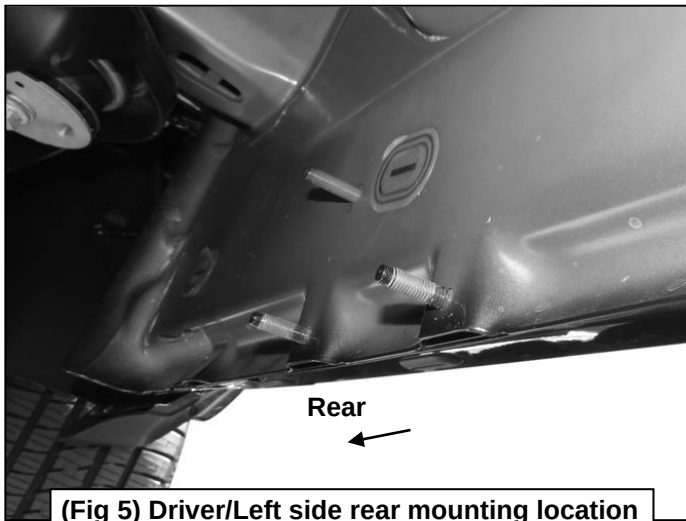
**(Fig 5) Driver/Left side rear mounting location**

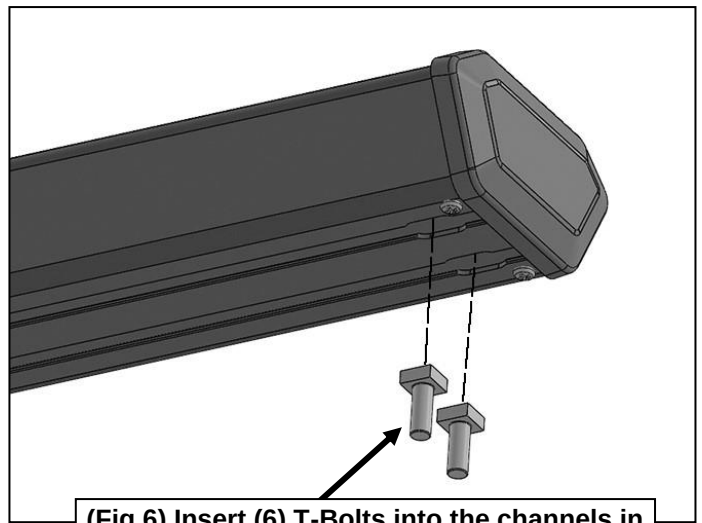
**(Fig 6) Insert (6) T-Bolts into the channels in the bottom of the Sidebar, (3) per channel**

5. Select (1) A4 Step Bars. Insert (6) T-Bolts into the channels in the bottom of the Sidebar, (3) per channel, **(Figure 6)**. Attach the Sidebar to the Mounting Brackets with (6) 8mm Flat Washers, (6) 8mm Lock Washers and (6) 8mm Hex Nuts, **(Figure 7)**.

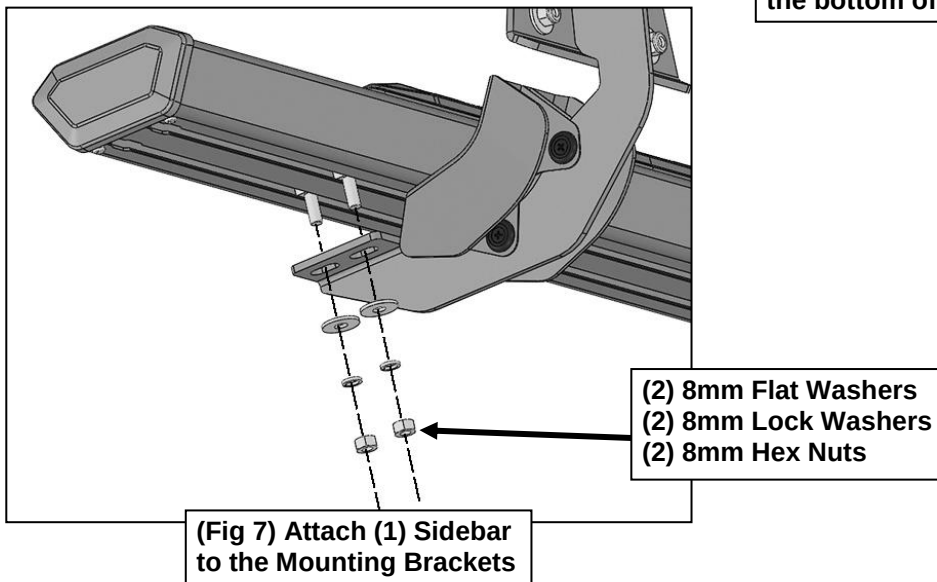
**(Fig 7) Attach (1) Sidebar to the Mounting Brackets**
