## Grille Guard

### Part No. 81020 /81021

Fits: **1999-2002 Chevrolet Silverado 1500**  
**2000-2006 Chevrolet Suburban 1500/ Tahoe 1500**  
**2000-2006 Chevrolet Tahoe Z71**

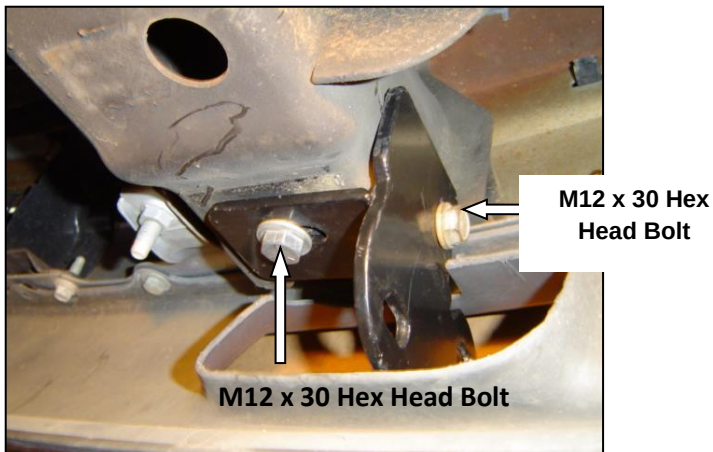
Figure 1

**Step Two:** Locate Left Lower Support Bracket, Two M12 x 30 Bolts, Two Lock Nuts, and Four Flat washers. Position bracket under the frame. Loosely attach the Left Lower Support Bracket to frame using the hardware listed in this step (Figure 1). Repeat this procedure on the opposite side of vehicle.

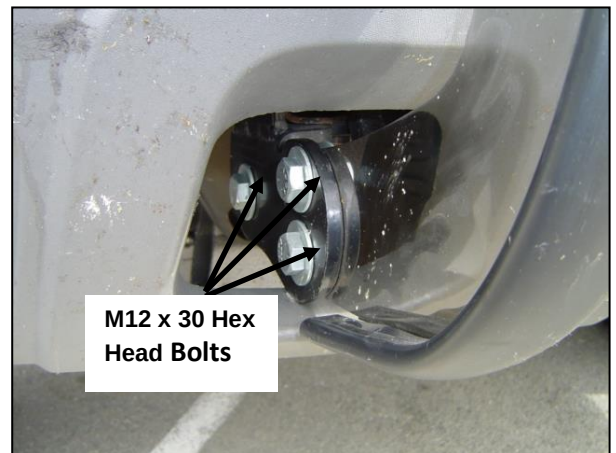
Figure 2

**Step Three:** Locate the remaining M12 hardware and position the Front Guard to the inside of the Support Brackets. Attach the Guard to the Support Brackets using the hardware listed in this step (Figure 2). Maintain a 3/16" gap between the guard and the vehicle's bumper.
