### Upper Control Arms, part # 51-304690

### Removal of OE Upper Control Arms (always follow service manual specifications)

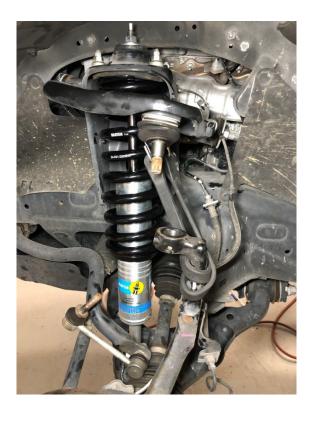
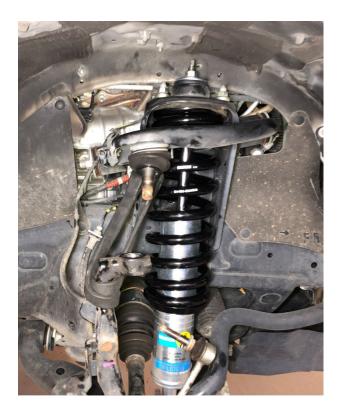
D. Remove cotter pin from upper ball joint castle nut. Using a 19mm wrench, loosen upper ball joint castle nut until flush with the end of the stud. Use a 17mm wrench to remove the nut holding the sway bar link to the spindle and a 12mm wrench to remove the brake line bracket from the spindle.

E. Using a ball joint puller, separate the spindle from the ball joint stem. Be careful to avoid tension on the brake line and ABS line.

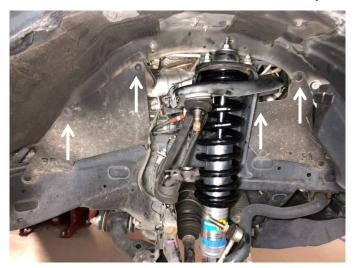
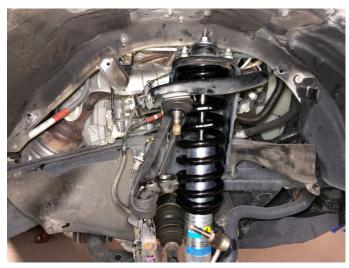
F. Using a clip tool, remove the top clips closest to the UCA bushings that secure the inner fender liners to the inner fender. Fold fender liners out of the way for access to the UCA bolt.

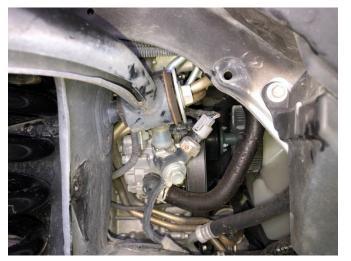
G. Using two 19mm wrenches, remove the nut and washer securing the UCA bolt.

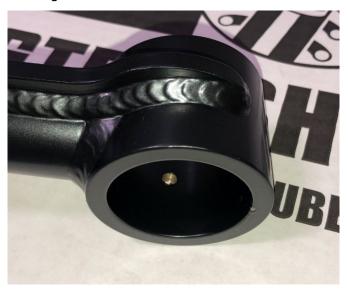
- I. Thoroughly clean and dry the UCA and provided bushings.
- J. Following the Bushing Assembly Instructions provided in the kit, use a shop press or vice to dry press the bushings into the UCAs.

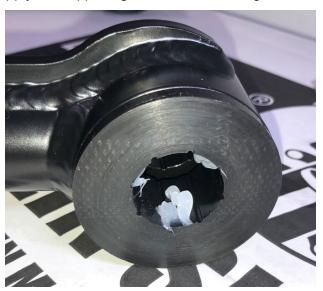
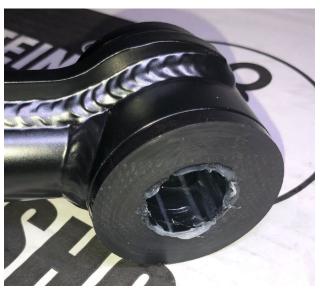
K. Apply the supplied grease to the bushing inside diameter.

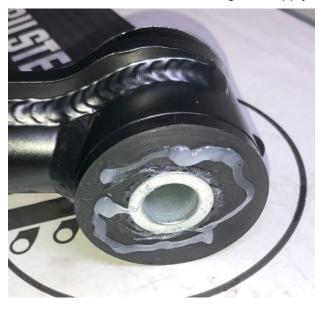
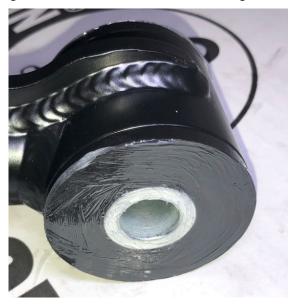
L. Press the steel sleeves into the bushings and apply more grease to outside faces of all bushings and sleeves.

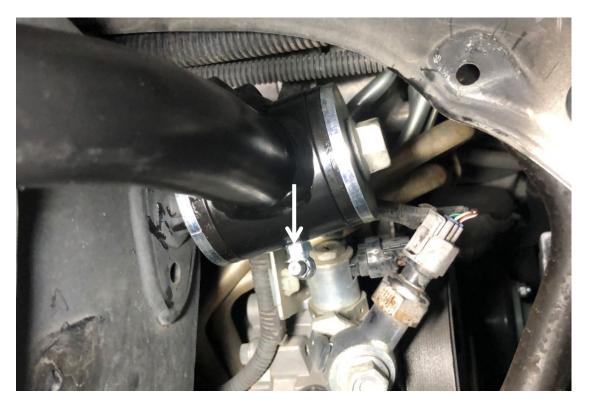
M. Install the 4 provided 90° zerk fittings into the threaded holes on the bottom of each bushing eye-ring ensuring they face outboard for easy access during service.

DO NOT OVER TORQUE ZERK FITTINGS. OVER TORQUING CAN RESULT IN DAMAGE TO FITTINGS.

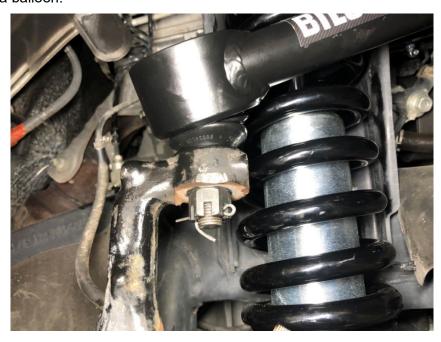
- O. Install UCA ball joint on the spindle and secure using castle nut provided. Torque castle nut to 110 Nm (81 ft-lbs.). Continue to tighten the castle nut to the next available slot (no more than 60°). Never back off the slotted nut to achieve alignment with the hole in the stud. Install and spread the cotter pin.
- P. Using a grease gun, apply Prothane Super Grease to the zerk fittings of the ball joints (do not over grease the joint or the ball joint boot will be damaged). Fill with grease until the boot starts to expand and the bottom of the boot sleeve seats against the spindle, and then add a little more. Do not fill to the point where the boot starts to look like a balloon.

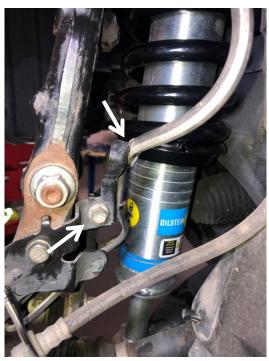
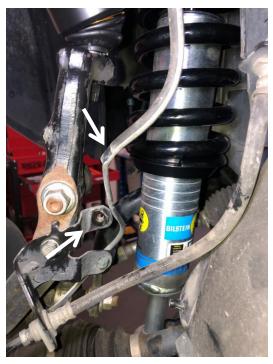
- Q. Reinstall the Sway bar link using a 17mm wrench. Reinstall the brake line bracket to the spindle using a 12mm wrench.
- R. Remove the ABS line from the ABS line bracket. Then remove ABS line bracket from the brake line bracket using a 10mm wrench.

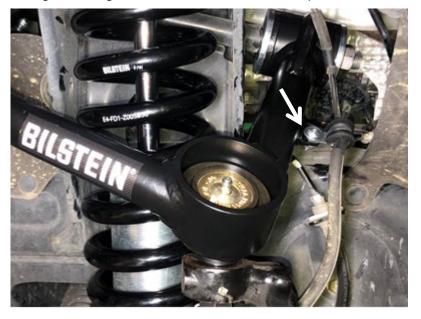
- S. Open the provided ABS line clamp and fit over the ABS line. The clamp should be wrapped around the thicker insulated hose segment, not the bare line to ensure a snug fit, as shown below.
- T. Mount the clamp to the Bilstein UCA mounting tab using the screws, washer and nuts provided.

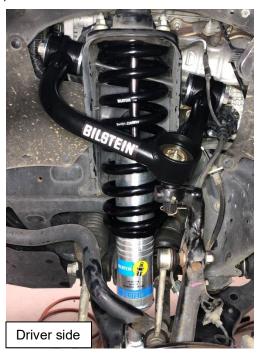
- U. Install wheels, lower to ride height, and torque to factory specification.
- v. Using a 19mm socket and 19mm wrench, torque UCA bolt and flanged nut removed in step H to 115 Nm (85 ft.-lbs.). (Torquing the UCA bolts while at droop, and not at ride height, may cause early wear to the bushings.)
