3" Side Bar

Part No. 1120240041/3

Fits: 2004 - 2010

Dodge Durango

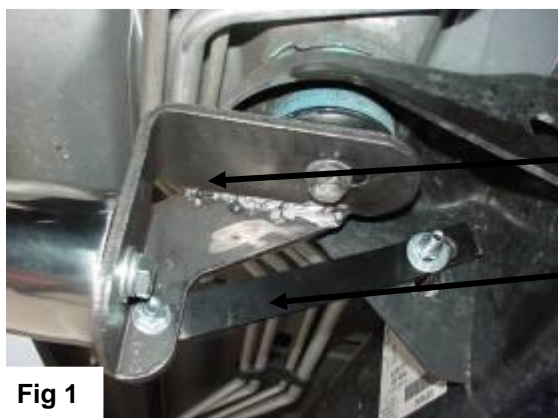
Passengers Side Front Mounting Bracket (looking towards the rear of the vehicle)

Passenger's side auxiliary bracket

4. Bolt the auxiliary bracket to the side of the vehicle frame and front main bracket using the 3/8" Hex Head Bolt, 3/8" flat washers, & 3/8" Lock Nuts. (See pictures). Do not tighten.

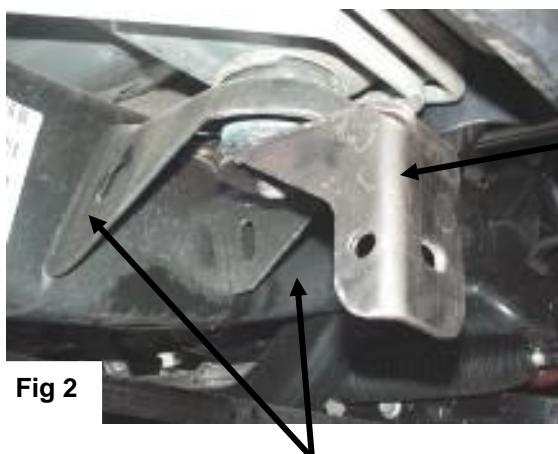
Passenger's Side Front Mounting Bracket (looking towards the front of the vehicle)

Auxiliary bracket bolt up to these holes

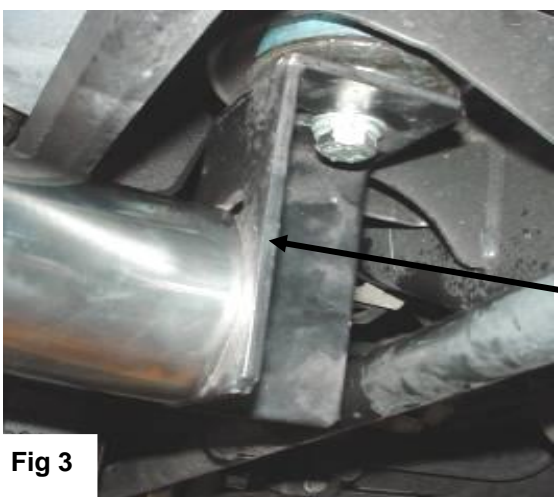
Passenger's side rear bracket

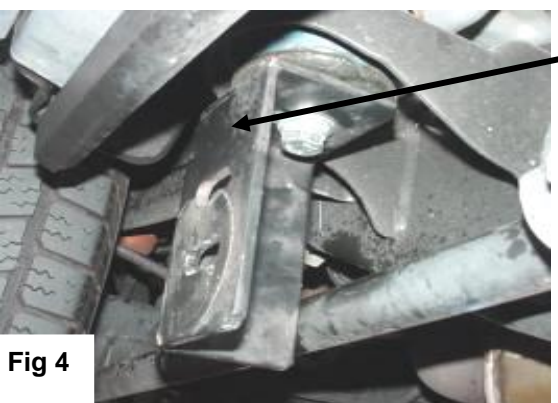
Passenger's side rear bracket (w/out tube mounted)

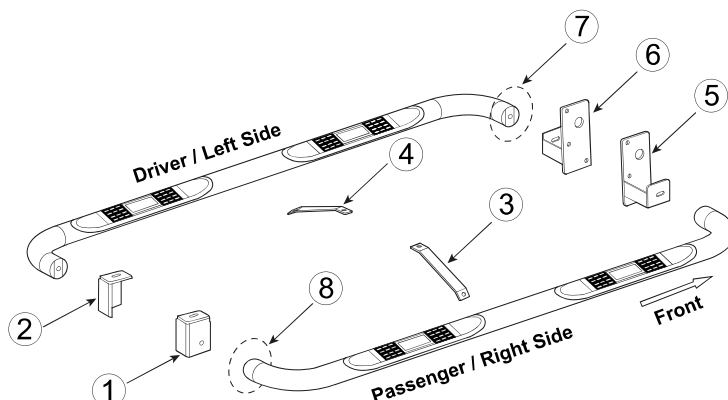
PARTS IDENTIFICATION GUIDE

Driver Side tube taped in "Red" Color. Passenger Side tube taped in "Blue" Color.

No.	Parts Identification
1	Passenger / Right 'Rear' Bracket marked "RR"
2	Driver / Left 'Rear' Bracket marked "RL"
3	Passenger / Right 'Center' Bracket marked "CR"
4	Driver / Left 'Center' Bracket marked "CL"
5	Passenger / Right 'Front' Bracket marked "FR"
6	Driver / Left 'Front' Bracket marked "FL"
7	'Left' marked "L"
8	'Right' marked "R"

In some cases Illustration images shown in Installation manual may not be the exactly same as per actual vehicle images ,also if Driver / Passenger side mounting brackets are very identical in the design, suggest referring Parts Identification guide to avoid fitment issue.

Side bar may be interchanged or mounting brackets are not installed at the correct position in the vehicle. Refer Parts identification guide.
