3" Side Bar

Part No. 1120240981/3

Fits: 1998-2003

Dodge Durango

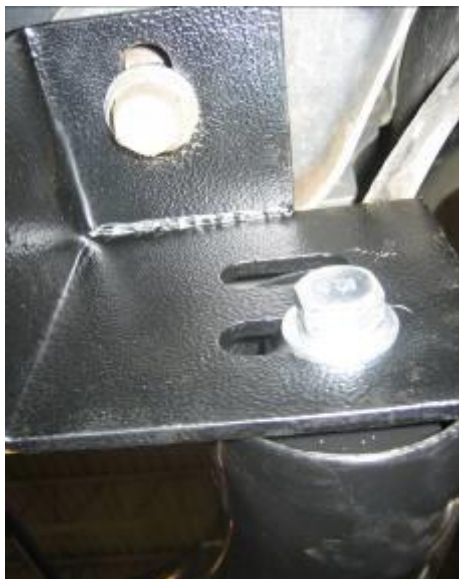
Passenger Side Rear Mounting Bracket

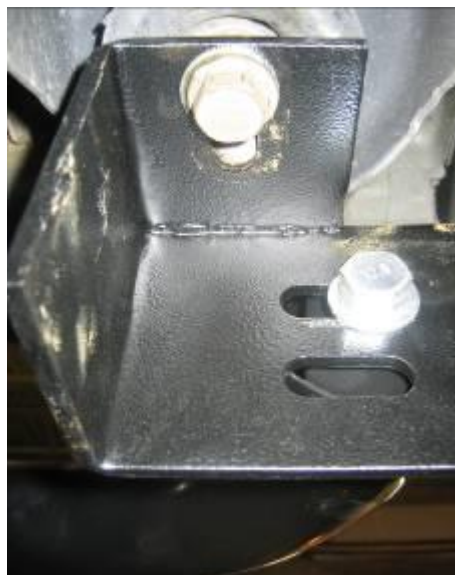
Driver Side Front Mounting Bracket

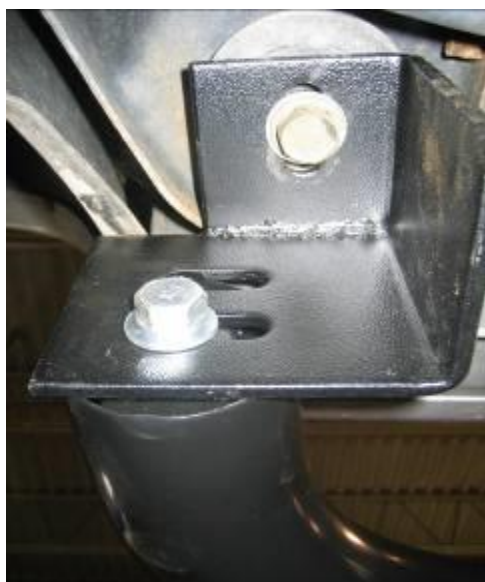
Driver Side Rear Mounting Bracket

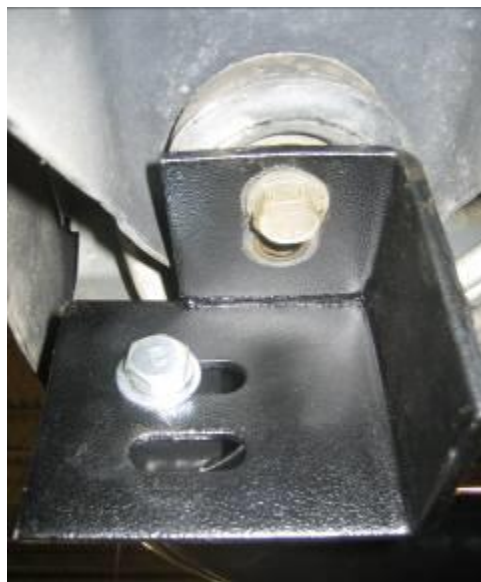
Passenger Side Front Mounting Bracket

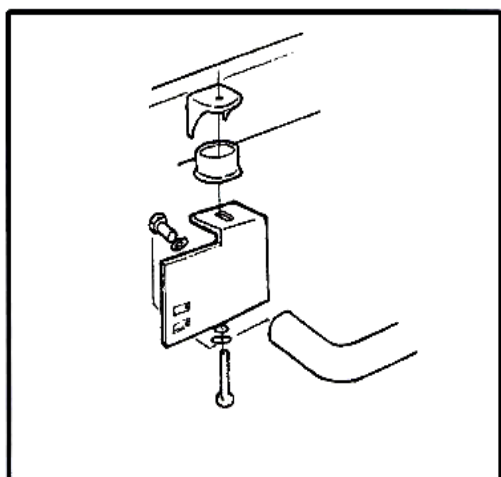
(See Illustration 1)

Driver's Side Front

1. Remove the end caps on the side bars before beginning installation.
2. Locate the correct Side Bar and set of Brackets referenced to the illustration. (See Illustration 1).
3. **Bracket Installation:** Locate the existing bolts on the correct body mounts of the chassis. Remove them and install the brackets. Use the M12x1.75x120mm Hex Head Bolts with the Flat and Lock Washers. Do not tighten. (See Illustration 1).
NOTE: There is a right and left bracket needed to mount sidebar. The outside edge of the bracket, which the sidebar attaches to, should face toward the tire.
4. **Side Bar Installation:** Hold the side bar up to the brackets and install using the 1/2" x 1 1/2" Hex Head Bolts with the Flat and Lock Washers. (See Illustration 1).
5. Tighten the body mount bolts. Then align the Side Bar and tighten the Side Bar bolts.
6. Recheck bolts periodically.

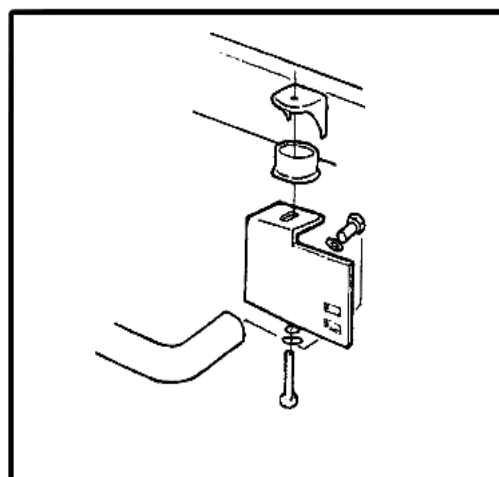
Driver's Side Rear

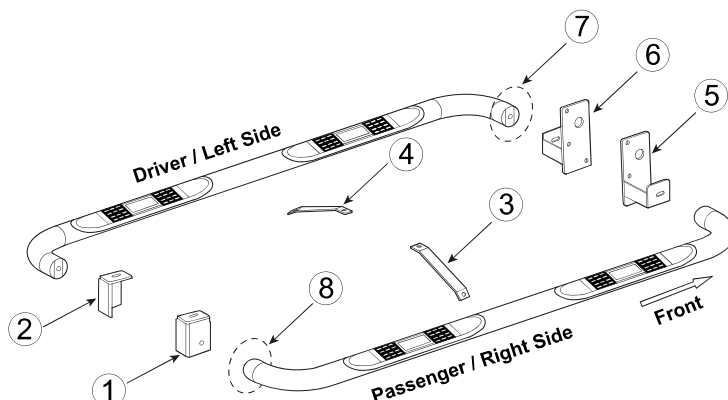
PARTS IDENTIFICATION GUIDE

Driver Side tube taped in "Red" Color. Passenger Side tube taped in "Blue" Color.

No.	Parts Identification
1	Passenger / Right 'Rear' Bracket marked "RR"
2	Driver / Left 'Rear' Bracket marked "RL"
3	Passenger / Right 'Center' Bracket marked "CR"
4	Driver / Left 'Center' Bracket marked "CL"
5	Passenger / Right 'Front' Bracket marked "FR"
6	Driver / Left 'Front' Bracket marked "FL"
7	'Left' marked "L"
8	'Right' marked "R"

In some cases Illustration images shown in Installation manual may not be the exactly same as per actual vehicle images ,also if Driver / Passenger side mounting brackets are very identical in the design, suggest referring Parts Identification guide to avoid fitment issue.

Side bar may be interchanged or mounting brackets are not installed at the correct position in the vehicle. Refer Parts identification guide.
