## 3" Side Bar

### Part No. 1130301971/3

Fits: **1997-2003**      **Ford F150 Standard Cab**  
**1997-2004**      **Ford F250 LD Standard Cab**

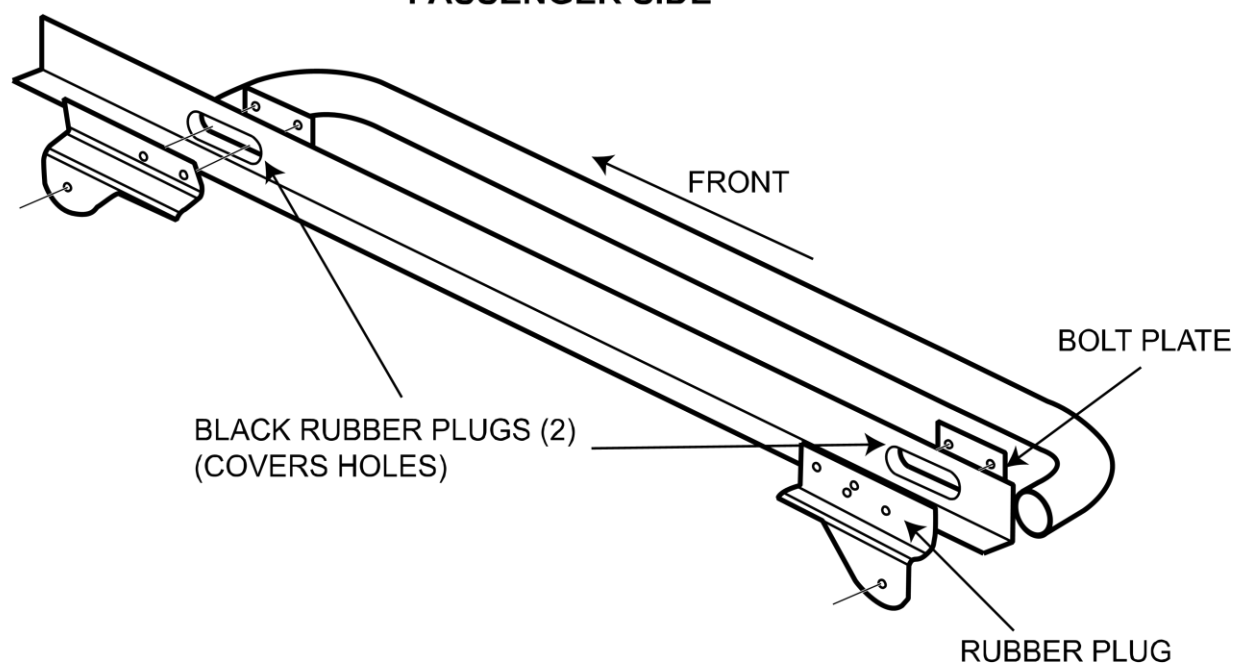
**FIGURE 1  
PASSENGER SIDE**

1. Remove the end caps on the side bars before beginning installation.
2. Remove the rubber plugs from the two holes on each inside face of the sheet metal rocker panel. (Figure 1).
3. Install the front mounting bracket by placing bolt plate through hole in body as shown in figure 1. Position front bracket with downward sloping end towards front of vehicle. Assemble with 3/8" flat washers, 3/8" lock washers and 3/8" hex nuts. (See Figure 1)
4. Install rear mounting bracket same as front only with the downward sloping end towards the rear of the vehicle.
5. Install the side bar using the 1/2" x 2 1/2" hex head bolts, 1/2" flat washers, and 1/2" lock washers.
6. After all mounting points are in place and Side Bars are aligned, tighten all bolts accordingly. Recheck bolts periodically.

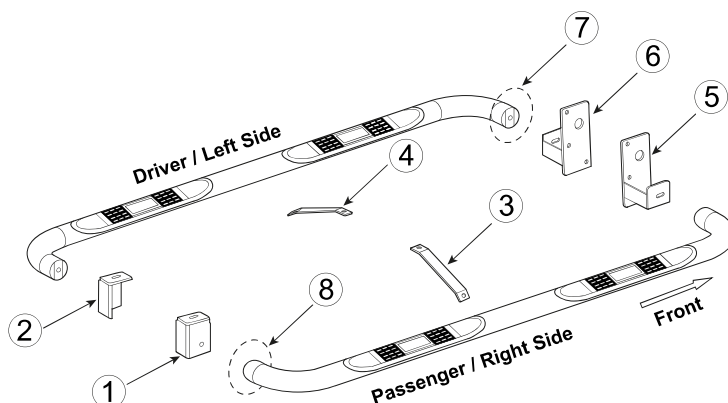
## PARTS IDENTIFICATION GUIDE

**Driver Side tube taped in "Red" Color. Passenger Side tube taped in "Blue" Color.**

No.	Parts Identification
1	Passenger / Right 'Rear' Bracket marked "RR"
2	Driver / Left 'Rear' Bracket marked "RL"
3	Passenger / Right 'Center' Bracket marked "CR"
4	Driver / Left 'Center' Bracket marked "CL"
5	Passenger / Right 'Front' Bracket marked "FR"
6	Driver / Left 'Front' Bracket marked "FL"
7	'Left' marked "L"
8	'Right' marked "R"

*In some cases Illustration images shown in Installation manual may not be the exactly same as per actual vehicle images ,also if Driver / Passenger side mounting brackets are very identical in the design, suggest referring Parts Identification guide to avoid fitment issue.*

*Side bar may be interchanged or mounting brackets are not installed at the correct position in the vehicle. Refer Parts identification guide.*
