3" Side Bar

Part No. 1130342991/3

Fits: 1999 - 2016

Ford F250/F350/F450/F550 Super Duty Crew Cab

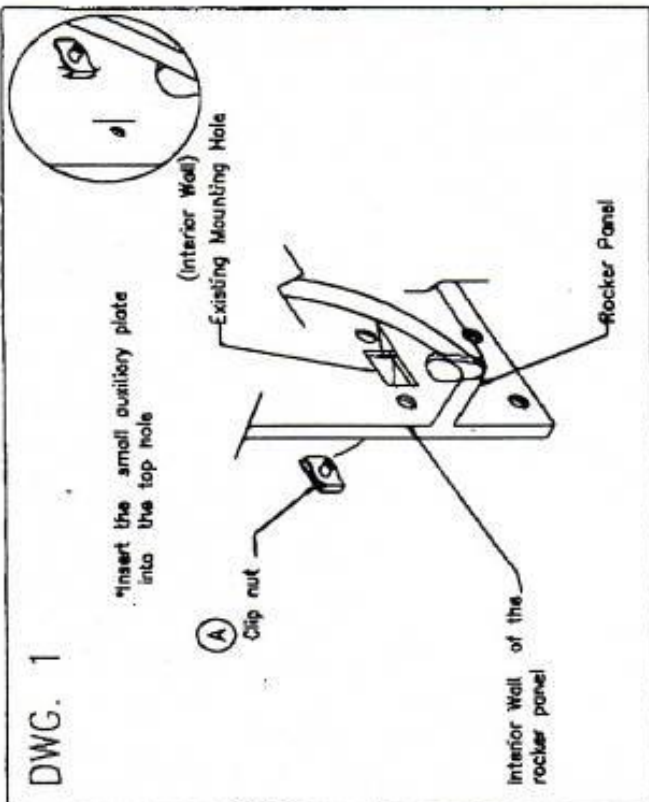
DWG. 1

1. Remove the end caps on the side bars before beginning installation.
2. First, install clip nut into the top hole on the interior wall of the rocker panel. The front and rear top hole patterns will be used for this installation as follows. (DWG. 1).

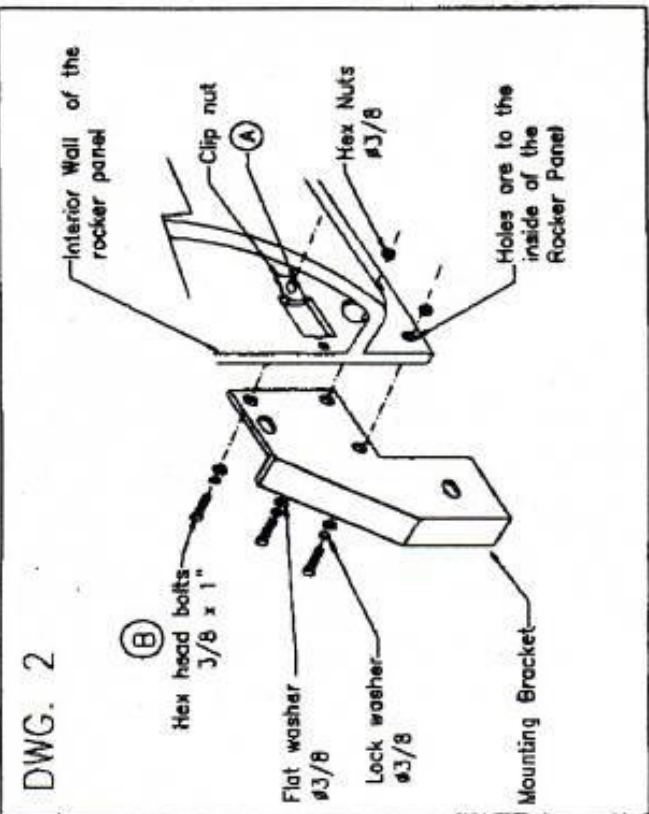
DWG. 2

3. Place the holding mounting bracket onto the interior wall of the rocker panel (DWG. 2) with the first 3/8" x 1" (B) hex head bolt, stopping the bracket from turning.

4. Once you have placed the mounting bracket onto the rocker panel, screw the last two 3/8" x 1" (B) hex head bolts into the existing holes that are to the inside of the rocker panel with the 3/8" lock washer, 3/8" flat washer, and 3/8" nut. (DWG. 2).

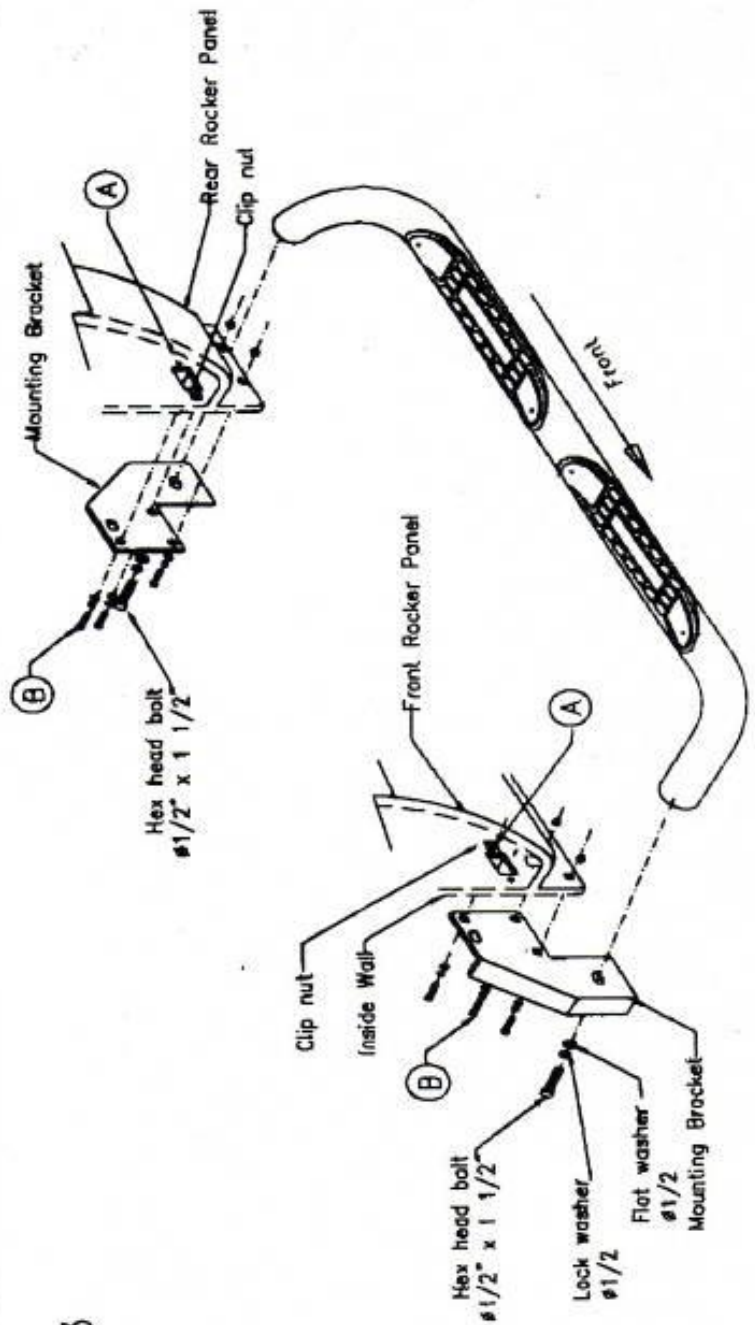
DWG. 3

5. Repeat this procedure for the remaining three brackets.
6. Position step bar assembly up to the mounting brackets (Front & Rear). Install using the 1/2" x 1 1/2" hex head bolts, lock washer, and flat washer. (DWG. 3).

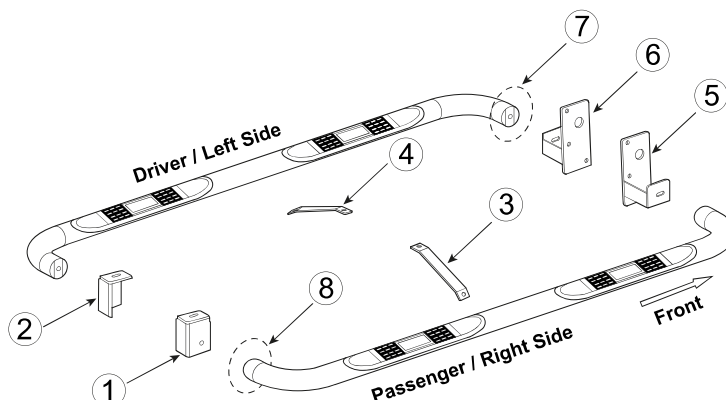
PARTS IDENTIFICATION GUIDE

Driver Side tube taped in "Red" Color. Passenger Side tube taped in "Blue" Color.

No.	Parts Identification
1	Passenger / Right 'Rear' Bracket marked "RR"
2	Driver / Left 'Rear' Bracket marked "RL"
3	Passenger / Right 'Center' Bracket marked "CR"
4	Driver / Left 'Center' Bracket marked "CL"
5	Passenger / Right 'Front' Bracket marked "FR"
6	Driver / Left 'Front' Bracket marked "FL"
7	'Left' marked "L"
8	'Right' marked "R"

In some cases Illustration images shown in Installation manual may not be the exactly same as per actual vehicle images ,also if Driver / Passenger side mounting brackets are very identical in the design, suggest referring Parts Identification guide to avoid fitment issue.

Side bar may be interchanged or mounting brackets are not installed at the correct position in the vehicle. Refer Parts identification guide.
