## 3" Side Bar

### Part No. 1170710061/3

Fits: **2006-2011****Hummer H3**

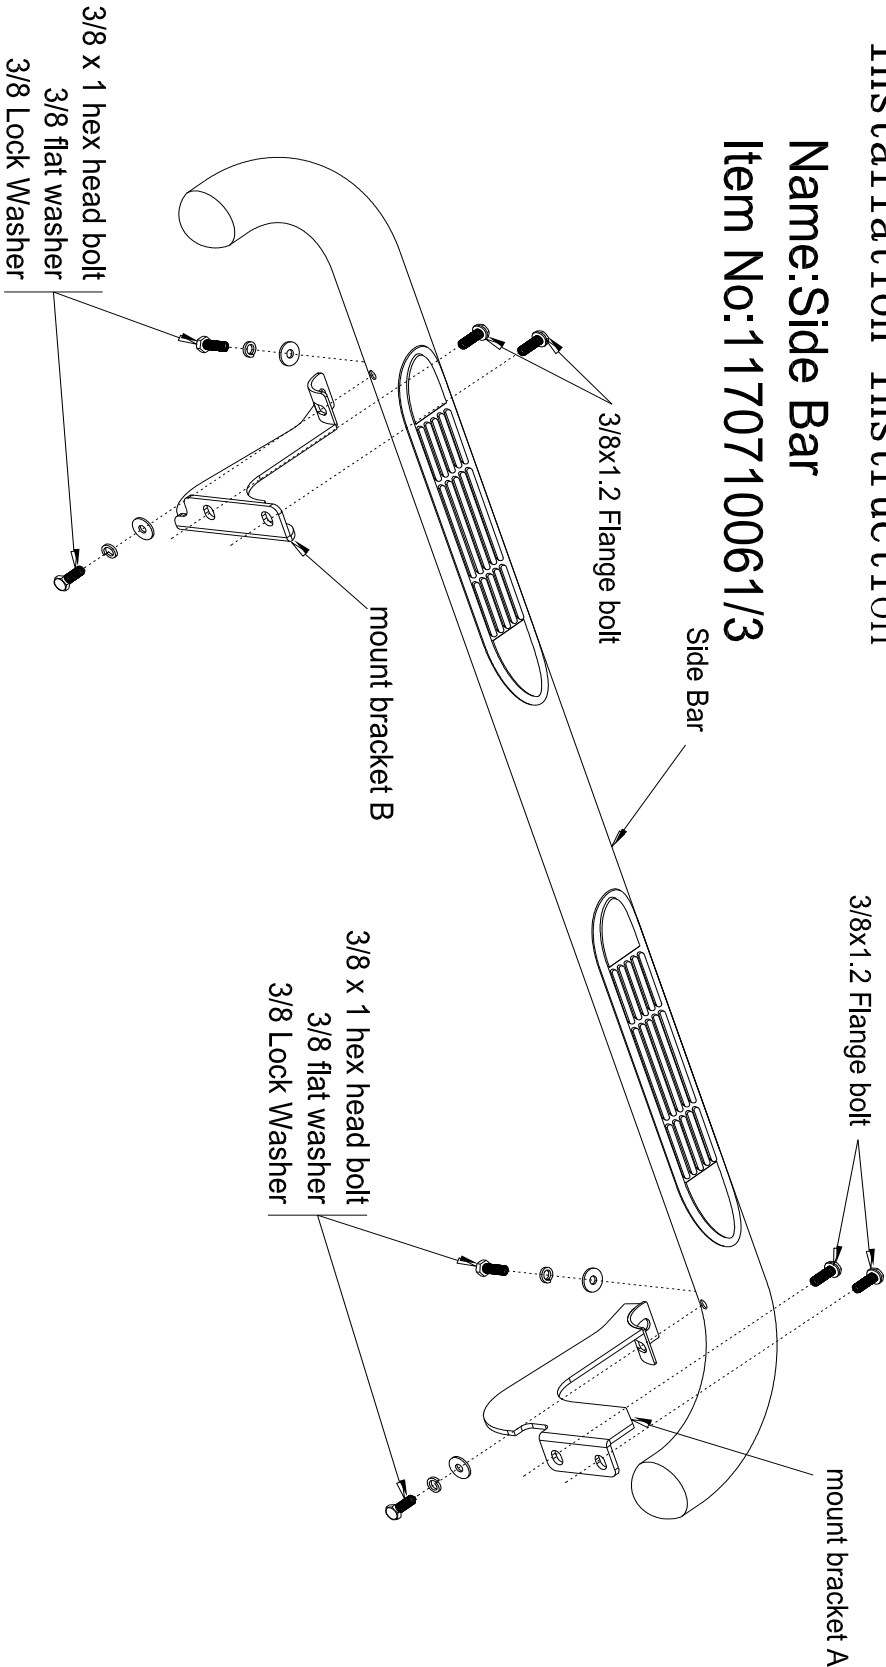
Installation Instruction

1. Remove the end caps on the side bars before beginning installation.
2. Locate the correct Side Bar and set of Brackets referenced to the illustration. (See Illustration).
3. Install mount bracket to frame using hardware as shown in figure. After you reading these steps, please refer to the installation drawing.
4. Recheck bolts periodically.

Side Bar		mount bracket A	mount bracket B	3/8x1.2 Flange bolt

2 pieces-lateral symmetry		2 pieces-lateral symmetry	2 pieces-lateral symmetry	8 pieces
		3/8x1 hex head bolt	3/8 flat washer	3/8 Lock Washer
		8 pieces	8 pieces	8 pieces

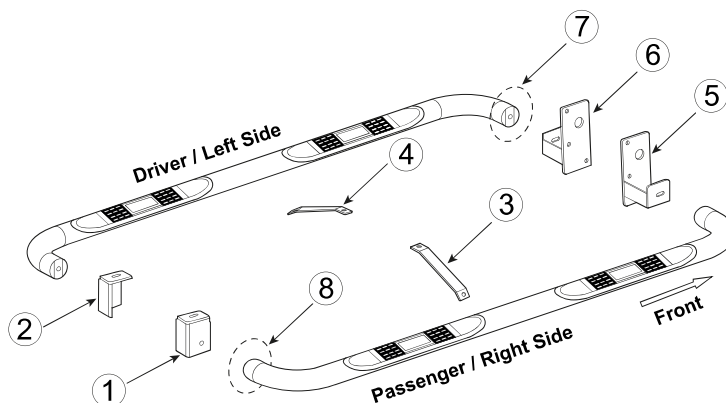
## PARTS IDENTIFICATION GUIDE

**Driver Side tube taped in "Red" Color. Passenger Side tube taped in "Blue" Color.**

No.	Parts Identification
1	Passenger / Right 'Rear' Bracket marked "RR"
2	Driver / Left 'Rear' Bracket marked "RL"
3	Passenger / Right 'Center' Bracket marked "CR"
4	Driver / Left 'Center' Bracket marked "CL"
5	Passenger / Right 'Front' Bracket marked "FR"
6	Driver / Left 'Front' Bracket marked "FL"
7	'Left' marked "L"
8	'Right' marked "R"

*In some cases Illustration images shown in Installation manual may not be the exactly same as per actual vehicle images ,also if Driver / Passenger side mounting brackets are very identical in the design, suggest referring Parts Identification guide to avoid fitment issue.*

*Side bar may be interchanged or mounting brackets are not installed at the correct position in the vehicle. Refer Parts identification guide.*
