4" Oval Nerf Bar

Part No. 2920232051/3

Fits: 2005-2010

Dodge Dakota-Quad Cab

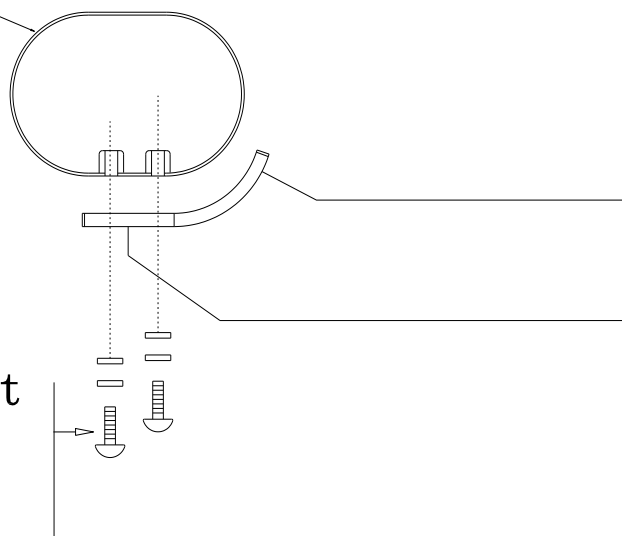
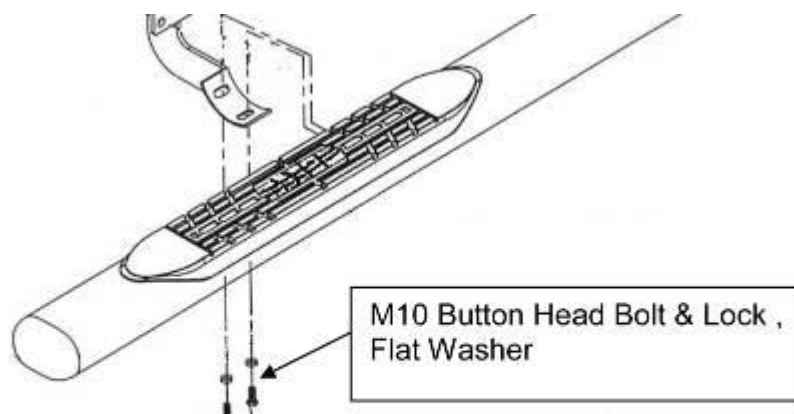
Figure 5. Installation View of Bracket & Bar

M10X30button head bolt
M10 flat washer
M10 lock washer

1. Remove existing body mount bolts as shown (see Fig. 1, 3, 4).
2. Install front and rear passenger brackets using M12-1.75 x 110mm Hex Bolt (see Fig 1, 4). Install center passenger bracket using spacer with M12-1.75 x 130 mm hex bolt.
3. Install support brace to front & rear bracket as shown. Attach support brace to vehicle body using M6 self drilling bolts (see Fig. 2).
4. Place passenger side step bar on brackets. Each step bar is marked driver and passenger.
5. Assemble with M10 button head bolts and M10 washers. 2 bolts per bracket, 4 bolt per bar (see Fig 5).
6. Repeat installation for driver side.

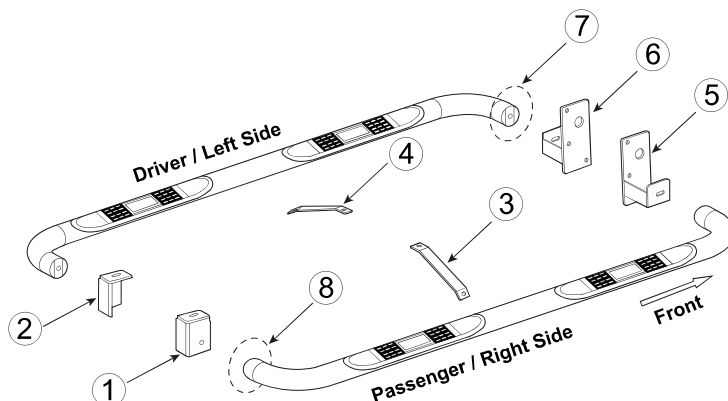
PARTS IDENTIFICATION GUIDE

Driver Side tube taped in "Red" Color. Passenger Side tube taped in "Blue" Color.

No.	Parts Identification
1	Passenger / Right 'Rear' Bracket marked "RR"
2	Driver / Left 'Rear' Bracket marked "RL"
3	Passenger / Right 'Center' Bracket marked "CR"
4	Driver / Left 'Center' Bracket marked "CL"
5	Passenger / Right 'Front' Bracket marked "FR"
6	Driver / Left 'Front' Bracket marked "FL"
7	'Left' marked "L"
8	'Right' marked "R"
