4" Oval Nerf Bar

Part No.2930308991/3

Fits: 1999 - 2003 Ford F150 Pickup - Super Cab

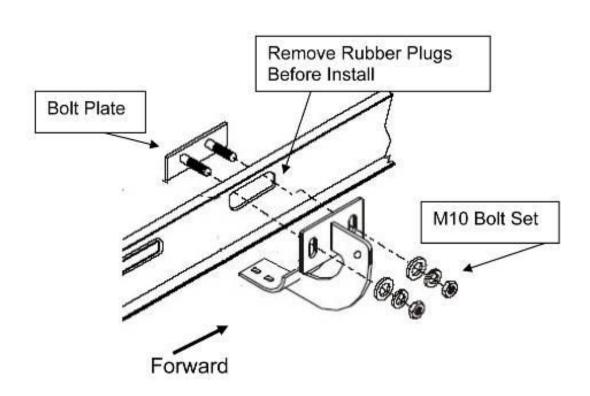
Figure 1. Driver Side - Front Bracket

- 1. Remove existing plug from underside of truck as shown. Fig. 1. 2.
- 2. Insert bolt plate as shown. Fig 1.2. Note: 97-98 extended cab driver side rear bracket uses smaller bolt plate and lower bracket holes. Fig, 3.
- 3. Install driver side front and rear bracket as shown. Fig 1. 2.
- 4. Place driver side step bar on brackets. Each step bar is marked driver and passenger.
- 5. Assemble with M10 button head bolts and M10 washers. 2 bolts per bracket, 4 bolts per bar. Fig. 4.
- 6. Repeat installation for passenger side.

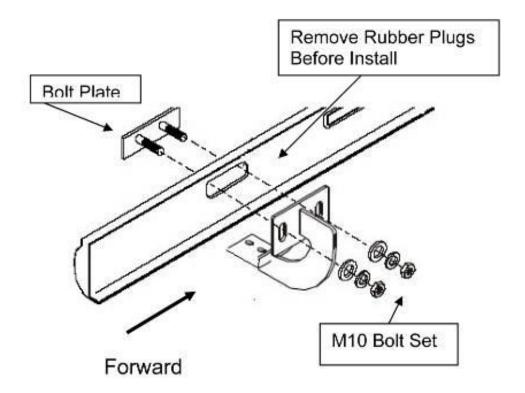
Figure 2. Driver Side - Rear Bracket

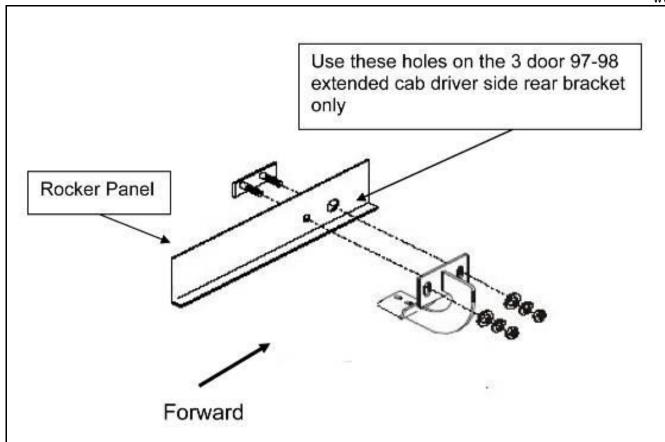
Figure 3. Driver Side - Rear Bracket

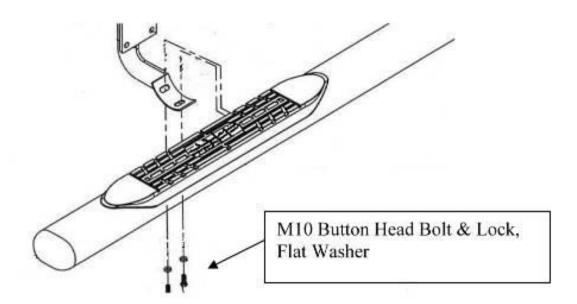
Figure 4. Installation View of Bracket & Bar

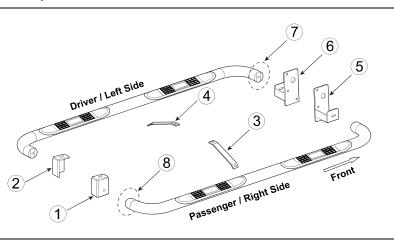
PARTS IDENTIFICATION GUIDE

Driver Side tube taped in "Red" Color. Passenger Side tube taped in "Blue" Color.

No.	Parts Identification	
1	Passenger / Right 'Rear' Bracket marked "RR"	
2	Driver / Left 'Rear' Bracket marked "RL"	
3	Passenger / Right 'Center' Bracket marked "CR"	
4	Driver / Left 'Center' Bracket marked "CL"	
5	Passenger / Right 'Front' Bracket marked "FR"	
6	Driver / Left 'Front' Bracket marked "FL"	
7	'Left' marked "L"	
8	'Right' marked "R"

In some cases Illustration images shown in Installation manual may not be the exactly same as per actual vehicle images ,also if Driver / Passenger side mounting brackets are very identical in the design, suggest referring Parts Identification guide to avoid fitment issue.

Side bar may be interchanged or mounting brackets are not installed at the correct position in the vehicle. Refer Parts identification guide.
