4" Oval Nerf Bar

Part No. 2940415051/3

Fits: **2005 - Current****Nissan Frontier Extended / King Cab**

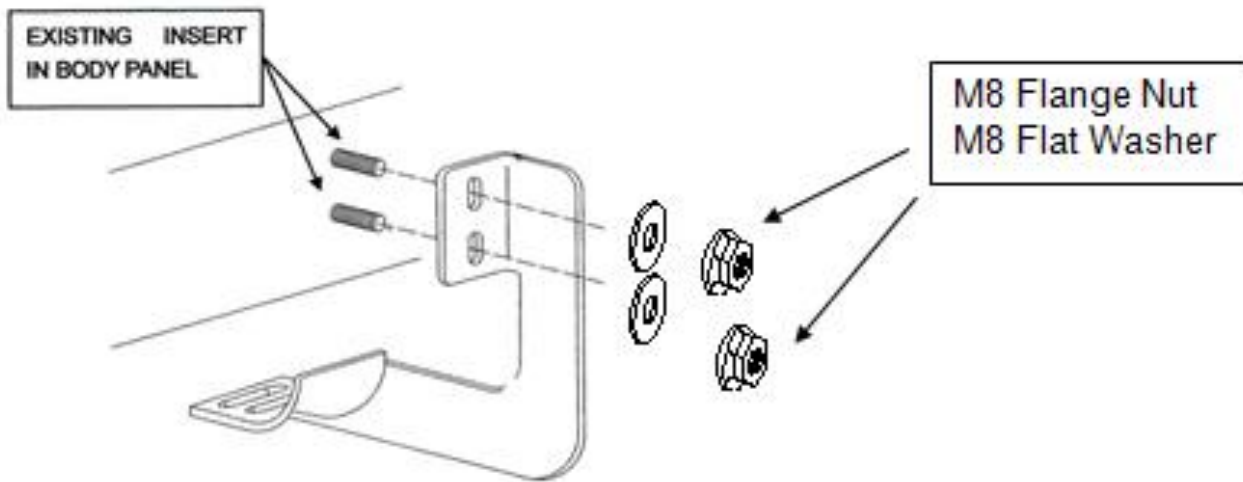
Figure 1. Driver Side – Front & Rear Bracket

- Determine driver side brackets. All driver side brackets are identical with metal cup facing toward the rear of the vehicle (see Fig. 1).
- Install driver side bracket closest to the front wheel first. Use one, M8 flat washer, M8 Flange Nut by attaching to underside of body panel. Hand tighten. Use existing factory hole in body panel for install (see Fig 1).
- Attach remaining driver side brackets to underside body panel by using 2 M8 Flange Nut, M8 flat washers per bracket. Hand tighten. Use existing factory holes in body panel (see Fig. 1).
- Place driver side step bar on brackets. Each step bar is marked driver and passenger.
- Assemble with M10 button head bolts and M10 lock washers. 2 bolts per bracket, 6 bolts per bar (see Fig 2). Hand tighten.
- Repeat installation for passenger side.

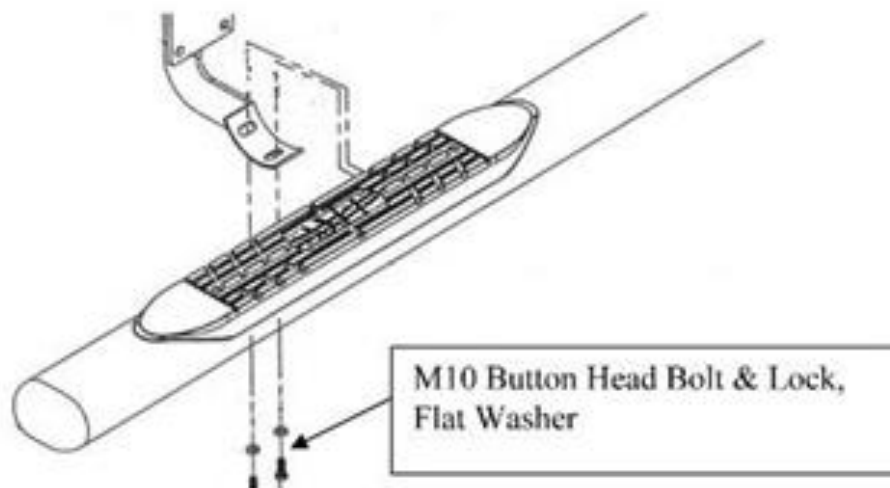
Figure 2. Installation View of Bracket & Bar

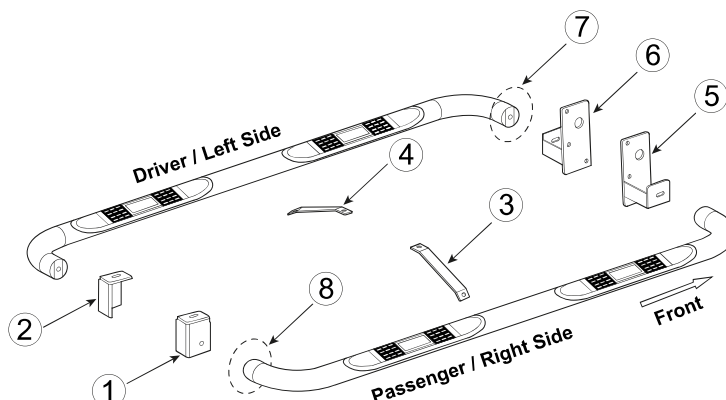
PARTS IDENTIFICATION GUIDE

Driver Side tube taped in "Red" Color. Passenger Side tube taped in "Blue" Color.

No.	Parts Identification
1	Passenger / Right 'Rear' Bracket marked "RR"
2	Driver / Left 'Rear' Bracket marked "RL"
3	Passenger / Right 'Center' Bracket marked "CR"
4	Driver / Left 'Center' Bracket marked "CL"
5	Passenger / Right 'Front' Bracket marked "FR"
6	Driver / Left 'Front' Bracket marked "FL"
7	'Left' marked "L"
8	'Right' marked "R"

In some cases Illustration images shown in Installation manual may not be the exactly same as per actual vehicle images ,also if Driver / Passenger side mounting brackets are very identical in the design, suggest referring Parts Identification guide to avoid fitment issue.

Side bar may be interchanged or mounting brackets are not installed at the correct position in the vehicle. Refer Parts identification guide.
