3" W2W Nerf Bar

Part No. 3012142001/3

Fits: 2000 - 2013 Chevrolet Silverado 1500/2500LD, Ext.Cab,4 door, Short Bed 6.6'

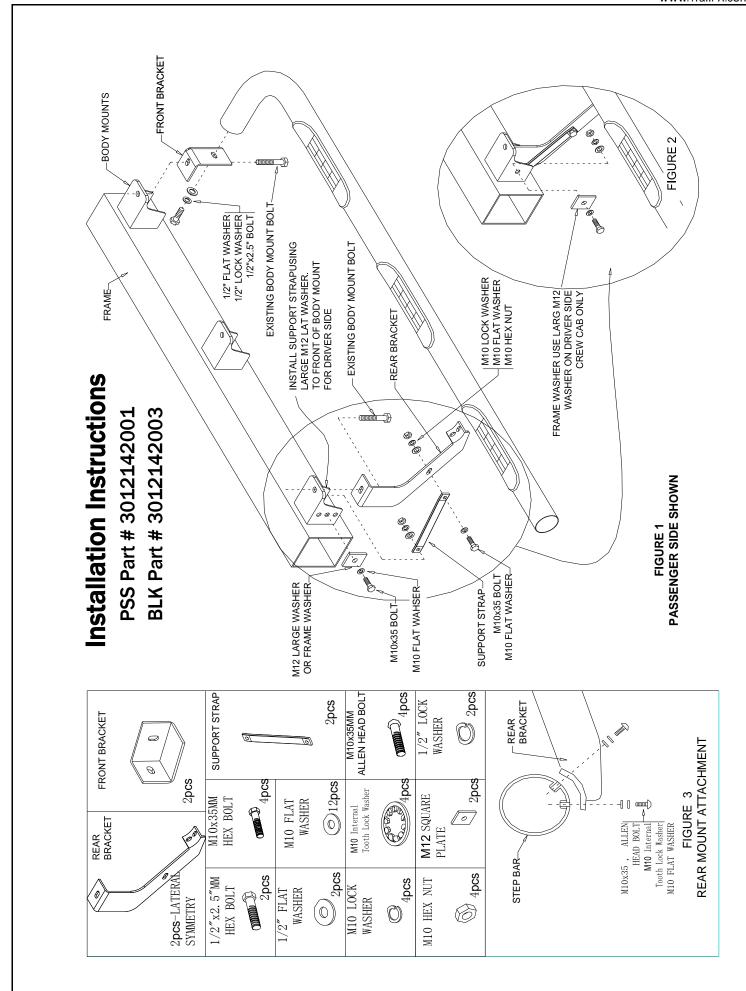
DRIVER (LEFT) FRONT	DRIVER (LEFT) REAR	PASSENGER (RIGHT) REAR	PASSENGER (RIGHT) FRONT	REAR SUPPORT BRACKET
			•	6

- 4. (Bracket Installation) Locate the existing bolts on the correct body mounts of the chassis. Remove them and install the brackets as shown (See Illustration1). You will need to tap out the existing body mount bolt from the bushing using a hammer. (See Illustration1). The body mount bolt will also need to be tapped back in when installing the mounting brackets. Install only hand tight at this point.

- 5. (Side Bar Installation) Hold the side bar up to the brackets and install using the 1/2"x2.5" Hex Head Bolts with the 1/2" Flat and Lock Washers. (See Illustration1)

- 1. A magnetic pick up tool is recommended to assist with the installation.
- 2. Remove the end caps on the side bars before beginning installation.
- 3. Locate the correct Side Bar and set of Brackets referenced to the illustration. (See Illustration 1).

- 6. Tighten the body mount bolts. Then align the Side Bar and tighten the Side Bar bolts.
- 7. Recheck bolts periodically.

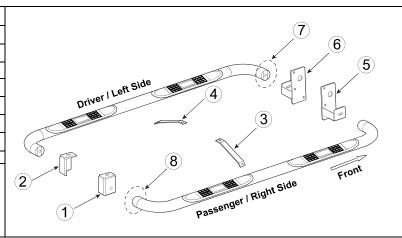
PARTS IDENTIFICATION GUIDE

Driver Side tube taped in "Red" Color. Passenger Side tube taped in "Blue" Color.

No.	Parts Identification	
1	Passenger / Right 'Rear' Bracket marked "RR"	
2	Driver / Left 'Rear' Bracket marked "RL"	
3	Passenger / Right 'Center' Bracket marked "CR"	
4	Driver / Left 'Center' Bracket marked "CL"	
5	Passenger / Right 'Front' Bracket marked "FR"	
6	Driver / Left 'Front' Bracket marked "FL"	
7	'Left' marked "L"	
8	'Right' marked "R"

In some cases Illustration images shown in Installation manual may not be the exactly same as per actual vehicle images ,also if Driver / Passenger side mounting brackets are very identical in the design, suggest referring Parts Identification guide to avoid fitment issue.

Side bar may be interchanged or mounting brackets are not installed at the correct position in the vehicle. Refer Parts identification guide.
