4" Oval Side Bar

Part No. A1539S/A1539B

Fits: 2000 - 2018 2000 - 2018 Chevrolet Silverado 1500 Extended Cab 4 & 3 Door Chevrolet Silverado 2500/3500 Extended Cab 4 & 3 Door

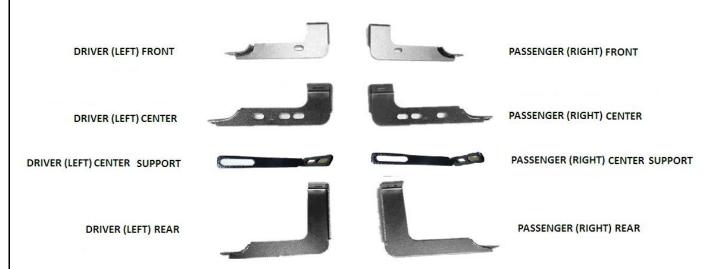
PARTS LIST:				
Qty	Part Description	Qty	Part Description	
1 Set	Oval step bar	2	M10-1.5 x 30mm Hex Head Bolt	
1 Set	Front bracket	6	M10-1.5 Flange Lock Nut	
1 Set	Center bracket	12	M10-1.5 x 30mm Button Head Bolt	
1 Set	Rear bracket	14	M10 Flat Washer	
1 Set	Support bracket	12	M10 Lock Washer	
2	M10-1.5 x 30mm "T" Bolt Plate	2	M14 x 140mm Hex Head Bolt	
2	Long support bracket	2	Spacer Block	
		6	Φ50 x Φ15 x 4.5 large spacer washer

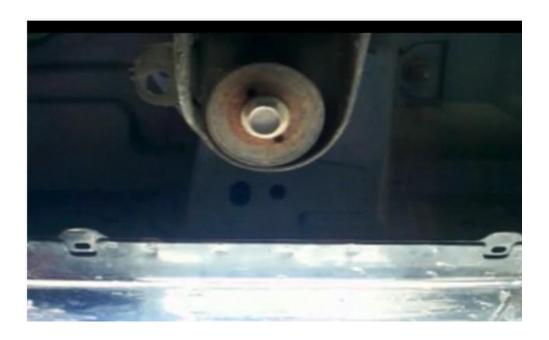
INSTALLTION OF T BOLT ON MID CHANNEL FOR MID SUPPORT BRACE

- 4. Insert bolts plate into mid holes inside support channel as shown Fig. B. Loosely attach support brace to bolt plate using flange lock nut(3) as shown Fig. A. Attach support brace to mid mounting bracket in center hole using hex bolt(1) flat washer(2) and flange lock nut(3) as shown in Fig. A.
- 5. Mount step bar to mounting brackets using hex head bolt(4), lock(5) flat(6) washers and rubber gasket(7) as shown. Hand tighten into nut sort on the bottom of the step bar. Adjust position of step bar and tighten all bolts.
- **6.** Torque the 10mm bolts to 30ft/lbs, the 10mm bolts and the factory bolts to 45ft/lbs.
