3" Nerf Bar

Part No. A0006S /B

**Fits: 2005-Current
2005-2012**

**Nissan Frontier King Cab
Suzuki Equator Extra Cab**

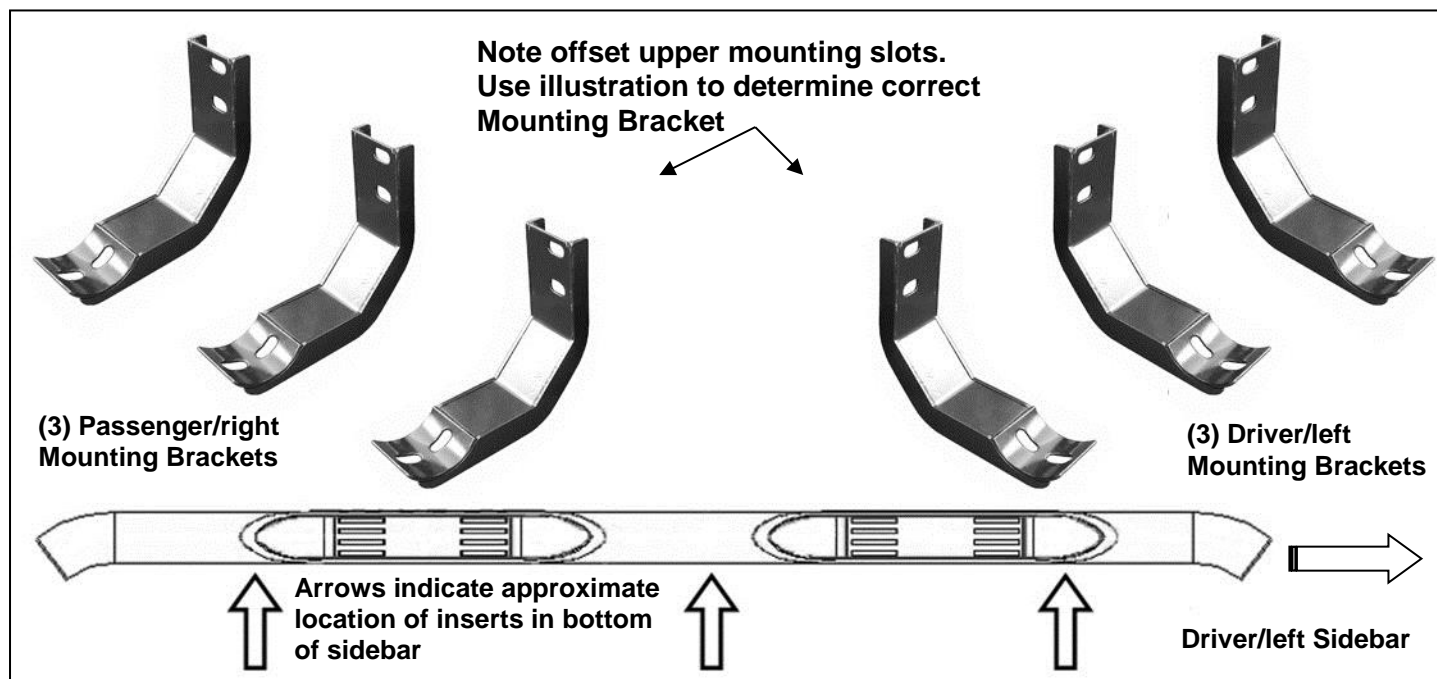
Qty	Part Description	Qty	Part Description
1	Driver/Left Side Bar	12	8-1.25mm x 25mm Combo Bolts
1	Passenger/Right Side Bar	12	8 x 24mm OD x 2mm Flat Washers
3	Driver/Left Side Mounting Brackets	12	8mm Lock Washers
3	Passenger/Right Side Mounting Brackets	12	8-1.25mm Hex Nuts

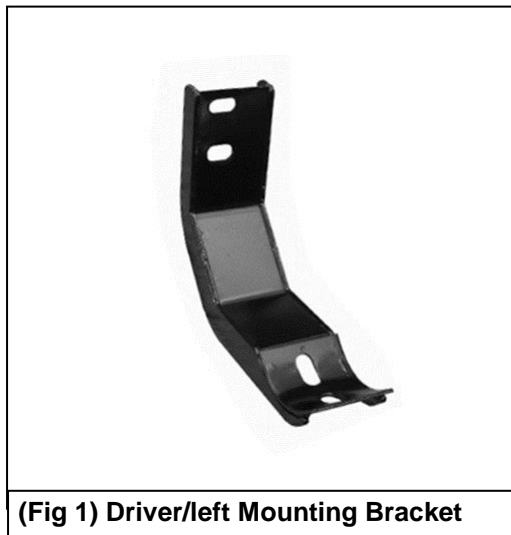
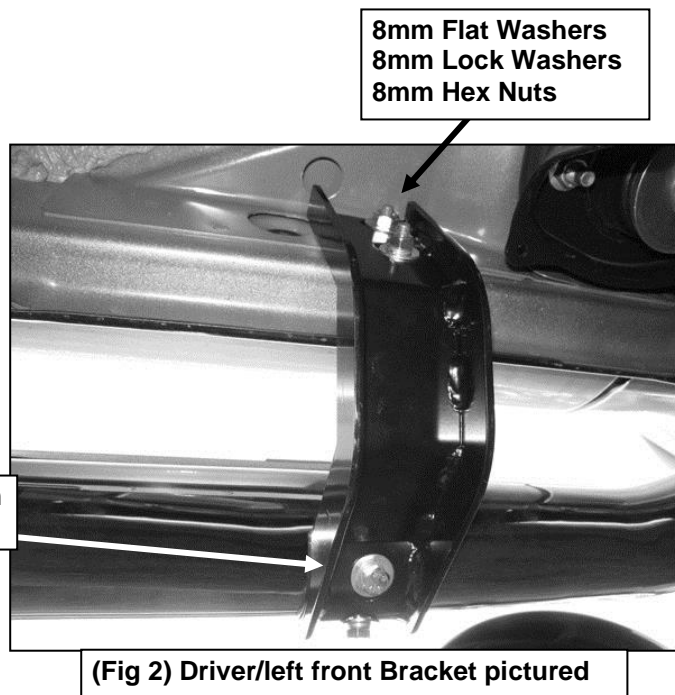
1. **REMOVE CONTENTS FROM BOX. VERIFY ALL PARTS ARE PRESENT. READ INSTRUCTIONS CAREFULLY.**
2. Remove the existing factory running boards or side steps, if equipped, by removing the hex nuts holding the mounting brackets to the inside of the body.
3. Select (1) the driver side Mounting Bracket, **(Figure 1)**. Attach the Bracket to the front mounting location, with the included (2) 8mm Flat Washers, (2) 8mm Lock Washers and (2) 8mm Hex Nuts, **(Figure 2)**. Do not tighten at this time.
NOTE: Slots in the top of the mounting brackets are off set. Use the illustration above to select the proper Mounting Bracket.

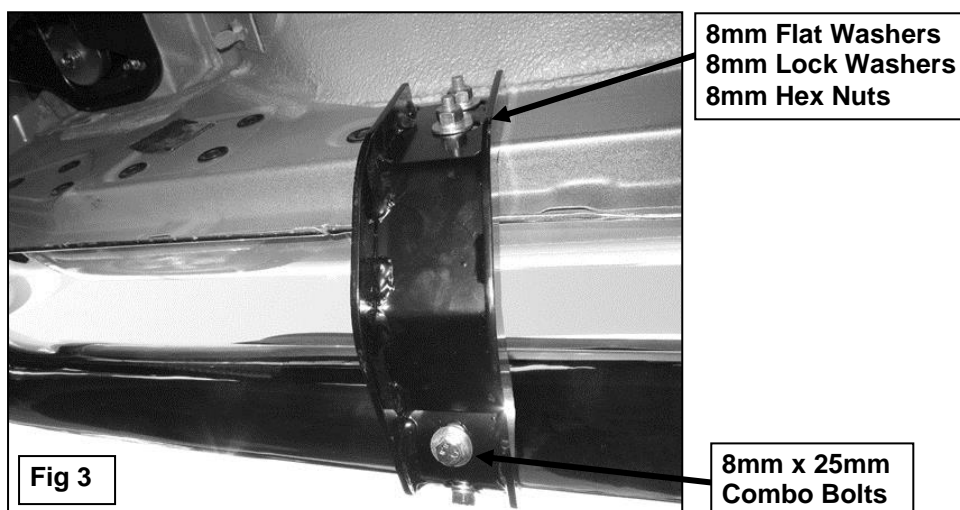
4. Repeat **Step 3** for the driver side center and rear Mounting Bracket installation, **(Figure 3)**.

5. Carefully place the driver Sidebar onto the (3) Mounting Brackets. Attach the Sidebar to the Brackets with the included (6) 8 x 25mm Combo Bolts. Do not tighten at this time.
6. Level and adjust the Sidebars as desired and tighten all hardware.
7. Repeat **Steps 2—6** for passenger Sidebar installation.
8. Do periodic inspections to the installation to make sure that all hardware is secure and tight.

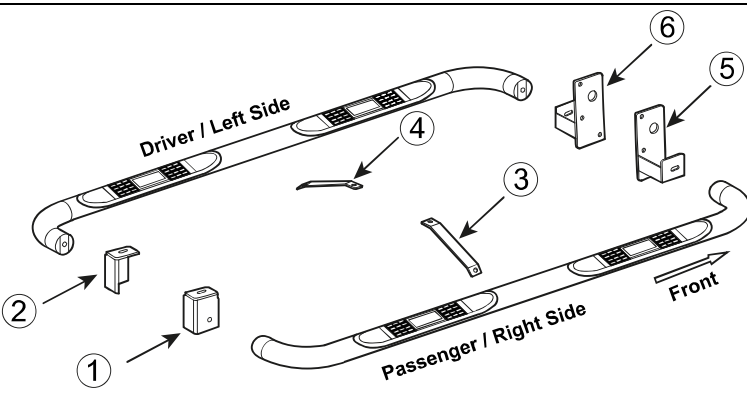
No.	Parts Identification

1	Passenger / Right 'Rear' Bracket marked "PR"	
2	Driver / Left 'Rear' Bracket marked "DR"	
3	Passenger / Right 'Center' Bracket marked "PC"	
4	Driver / Left 'Center' Bracket marked "DC"	
5	Passenger / Right 'Front' Bracket marked "PF"	
6	Driver / Left 'Front' Bracket marked "DF"	
Note: > This guide is to identify the parts and not a reference for part count. > For part count, refer Parts List. > Product / Bracket image is representative and actual design may vary.

In some cases Illustration images shown in Installation manual may not be the exactly same as per actual vehicle images ,also if Driver / Passenger side mounting brackets are very identical in the design, suggest referring Parts Identification guide to avoid fitment issue.

Side bar may be interchanged or mounting brackets are not installed at the correct position in the vehicle. Refer Parts identification guide.
