3" Nerf Bar

Part No. A0029S/B

Fits: 1999-Current Chevrolet Silverado 1500 Regular Cab

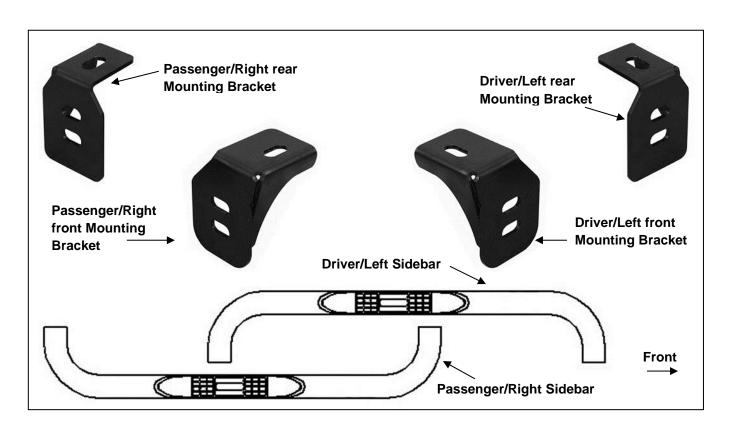
PARTS LIST:				
Qty	Part Description	Qty	Part Description	
1	Driver/Left Side Bar	1	Passenger/Right Rear Mounting Bracket	
1	Passenger/Right Side Bar	4	1/2" x 1-1/2" OD x 1/8" Large Flat Washers	
1	Driver/Left Front Mounting Bracket	4	1/2" Lock Washers	
1	Passenger/Right Front Mounting Bracket	4	1/2" x 2" Hex Bolts	
1	Driver/Left Rear Mounting Bracket

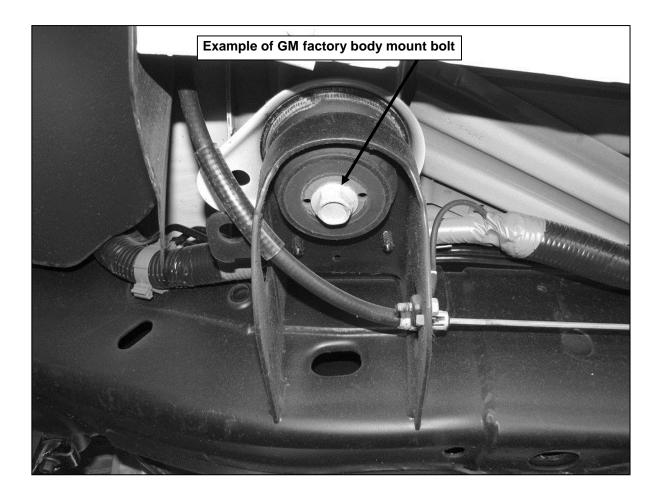
- 1. Start installation on the front, passenger side of the vehicle. Remove the factory front body mount bolt, (Figure 1).
- 2. Select the passenger side front Mounting Bracket, (Figure 2). Insert the body mount bolt through the Mounting Bracket, factory washer and up into the mount, (Figure 3). Snug but do not fully tighten the body bolt at this time. VERY IMPORTANT! To prevent unnecessary noise, adjust the position of all Mounting Brackets so that once tightened, the Mounting Brackets cannot come in contact with the factory steel body mount bracket.

CRITICAL INFORMATION: If during the removal process, it becomes increasingly difficult to unscrew the body mount bolt with hand tools, tighten the bolt several rotations to clear the thread locking compound from the threads, then reverse direction and continue to unscrew until the body mount bolt is out. Repeat this process as necessary on all GM body mount bolts. Use of an appropriate anti-seize compound is highly recommended for re-installation. Tighten body mount bolt to factory torque specifications for your particular model year.

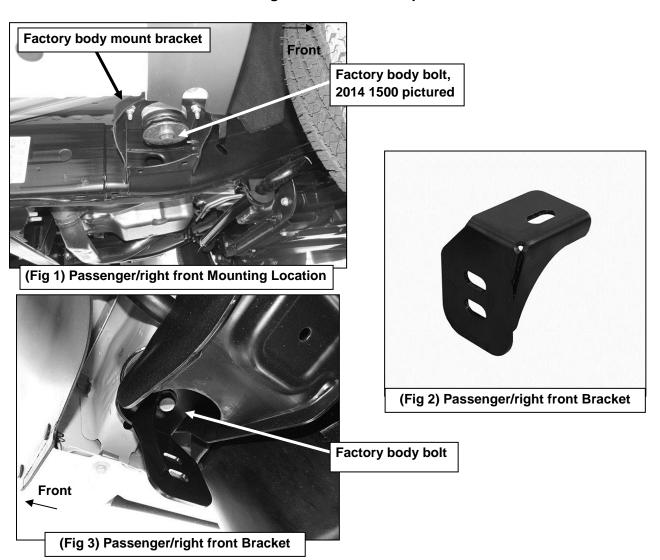
Passenger side installation pictured

- 3. Move toward the rear of the vehicle. Remove the factory body mount bolt as described in **Step 1**. Select the driver side Rear Mounting Bracket, **(Figure 4)**. Bolt the rear Mounting Bracket in place as previously described in **Step 2**, **(Figure 5)**.

- **4.** With assistance, position the Sidebar up to the front and rear Mounting Brackets. **IMPORTANT**: There are two slots in each Mounting Bracket, **(Figure 4)**. Select the appropriate mounting position:

1999-2013 1500: Use the lower mounting slots.

2014-on 1500: Use the upper mounting slots.

1999-2015 25-3500: Use the lower mounting slots

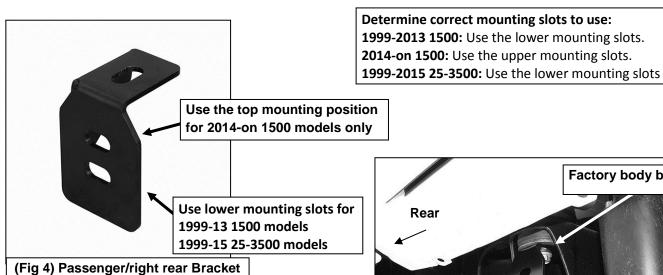
Passenger side installation pictured

Front
(Fig 6) Passenger/right front Bracket

1/2" x 2" Hex Bolt 1/2" Lock Washer 1/2" Flat Washer

(Fig 7) Passenger/right rear Bracket

Attach the Sidebar to the Brackets with the included (2) 1/2" x 2" Hex Bolts, (2) 1/2" Lock Washers and (2) 1/2" Flat Washers, (Figures 6 & 7). Do not tighten hardware at this time.
