# 5" Oval Nerf Bar Part No. A7052S/B

**Chevrolet Colorado Extended Cab**

2015 - Current GMC Canyon Extended Cab

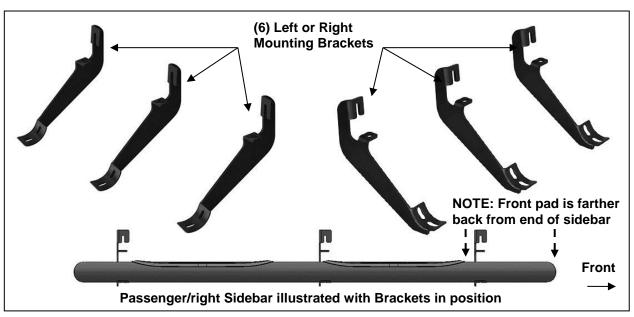
PARTS LIST:				
Qty	Part Description	Qty	Part Description	
1	Driver/left Sidebar	24	8-1.25mm x 25mm Hex Bolt	
1	Passenger/right Sidebar	24	8mm x 24mm x 2mm Flat Washer	
6	Sidebar Brackets (use for left or right)	24	8mm Lock Washer	
12	8-1.25mm Clip-On Nuts

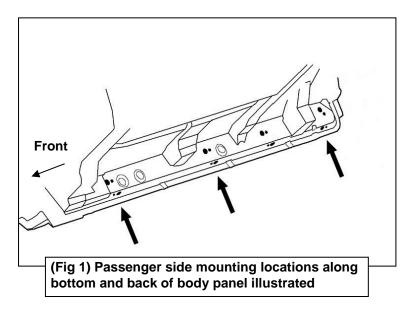
1. Start the installation under the passenger side of the vehicle. Locate the 4 factory running board mounting locations along the bottom and inner side of the body, (Figure 1). Mounting Brackets will bolt to the 1st, 2nd and 4th mounting locations. NOTE: It may help to hold a Bracket up in place to help determine the mounting holes to use along the bottom and inner side of the body.

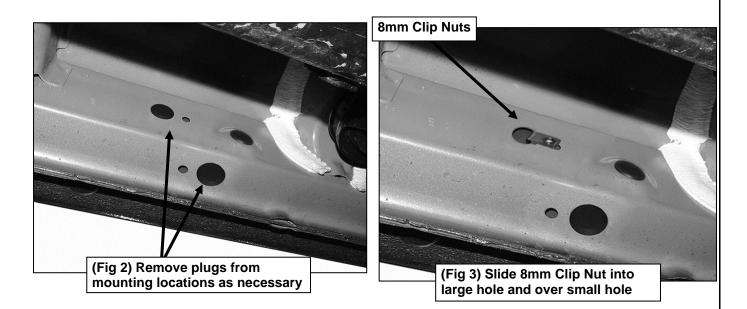
2. Remove rubber plugs as necessary, (Figure 2). Select (1) 8mm Clip Nut. Slide the Clip Nut into the large hole and over the smaller hole next to it. Line up threaded nut on the Clip Nut with smaller hole in body panel, (Figure 3).

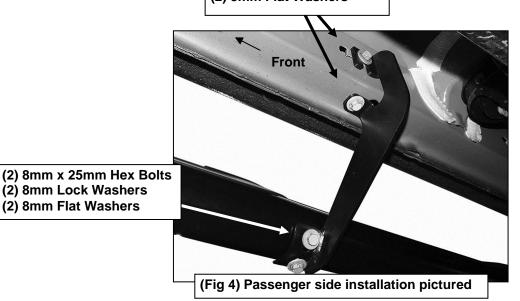
Select (1) Mounting Bracket. NOTE: All (6) Brackets are universal and will fit left or right side. Bolt the Mounting Bracket to the (2) Clip Nuts with (2) 8mm Hex Bolts, (2) 8mm Lock Washers and (2) 8mm Flat Washers, (Figure 4). Snug but do not fully tighten the hardware.
