5" Oval Bend End Bar

Part No. A7081S /B

Dodge Ram 1500 Crew Cab

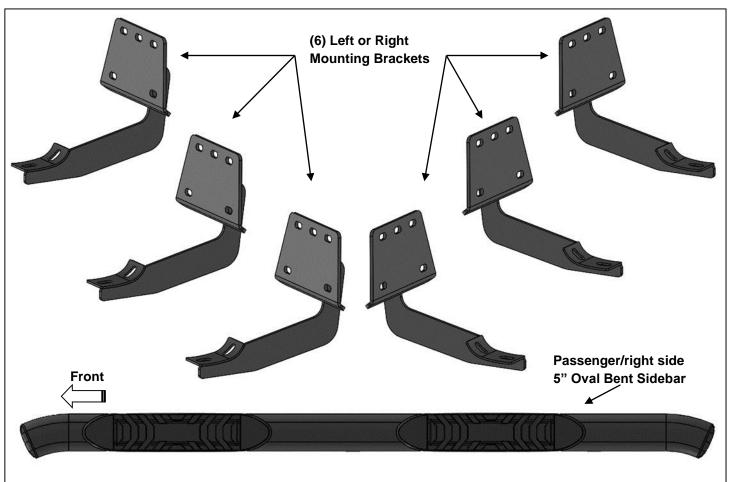
Qty	Part Description	Qty	Part Description
1	Driver/left side 5" Oval Bent End Sidebar	12	8-1.25mm x 25mm Combo Hex Bolts
1	Passenger/right side 5" Oval Bent End Sidebar	18	8mm x 24mm x 2mm Flat Washers
6	Mounting Brackets	18	8-1.25mm Nylon Lock Nuts

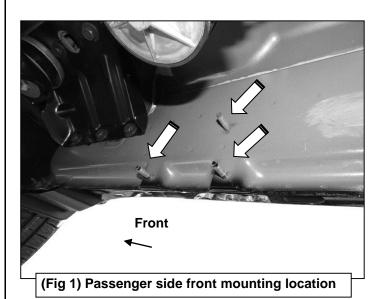
- 1. Start the installation under the passenger side of the vehicle. Locate the front (3) factory studs along the inner side of the body panel, (Figure 1).

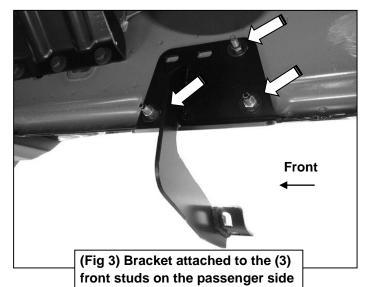
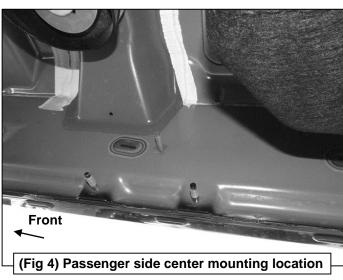
- 2. Select (1) Mounting Bracket. **NOTE**: All (6) Brackets are universal and will fit left or right side. Attach the Mounting Bracket to the (3) factory studs with (3) 8mm Flat Washers and (3) 8mm Nylon Lock Nuts, **(Figures 2 & 3)**. Leave brackets loose at this time.

(3) 8mm Flat Washers

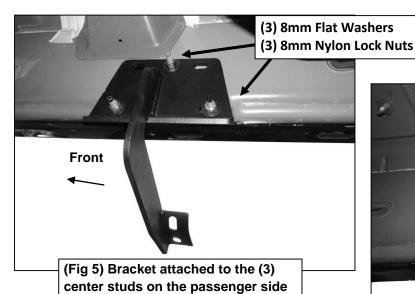
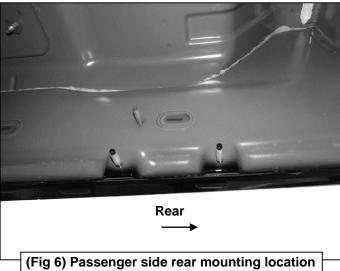
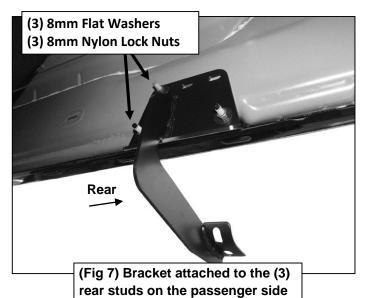
- 3. Repeat **Steps 1 & 2** to install the Universal Brackets in the center and rear mounting locations along the body panel, **(Figure 4—7)**.
- 4. Carefully unwrap and select the Passenger/right Sidebar. Use the illustration above to help identify the correct Sidebar. Place the Sidebar on top of the Brackets. **IMPORTANT**: Do not slide, (front to back or rotate), the Sidebar on the Brackets or damage to the finish on the Sidebar may result.

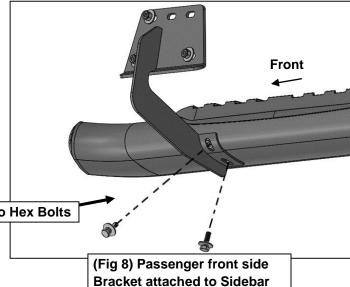
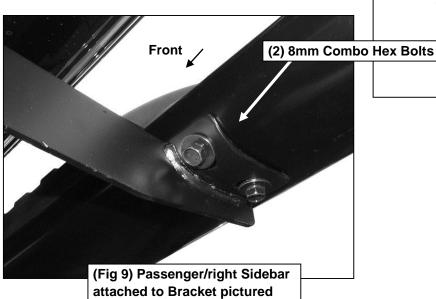
- 5. Attach the Sidebar to the Brackets with (6) 8mm Combo Hex Bolts, (Figures 8 & 9). Do not tighten hardware at this time.
- 6. Level and adjust the Sidebar as necessary and fully tighten all hardware.

Bracket attached to Sidebar

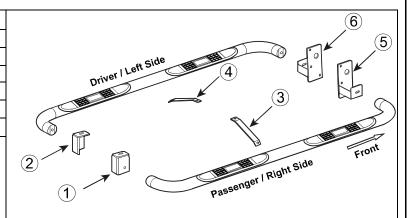
No.	Parts Identification			
1	Passenger / Right 'Rear' Bracket marked "PR"			
2	Driver / Left 'Rear' Bracket marked "DR"			
3	Passenger / Right 'Center' Bracket marked "PC"			
4	Driver / Left 'Center' Bracket marked "DC"			
5	Passenger / Right 'Front' Bracket marked "PF"			
6	Driver / Left 'Front' Bracket marked "DF"

In some cases Illustration images shown in Installation manual may not be the exactly same as per actual vehicle images ,also if Driver / Passenger side mounting brackets are very identical in the design, suggest referring Parts Identification guide to avoid fitment issue.

Side bar may be interchanged or mounting brackets are not installed at the correct position in the vehicle. Refer Parts identification guide.
