5" Oval Bend End Bar

Part No. A7082S/B

Dodge Ram 1500 Crew Cab

Fits: 2019

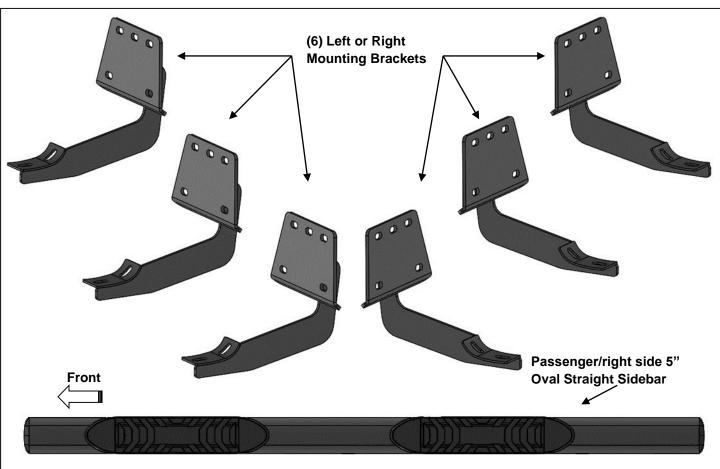
PARTS LIST:				
Qty	Part Description	Qty	Part Description	
1	Driver/left side 5" Oval Straight Sidebar	12	8-1.25mm x 25mm Combo Hex Bolts	
1	Passenger/right side 5" Oval Straight Sidebar	18	8mm x 24mm x 2mm Flat Washers	
6	Mounting Brackets	18	8-1.25mm Nylon Lock Nuts

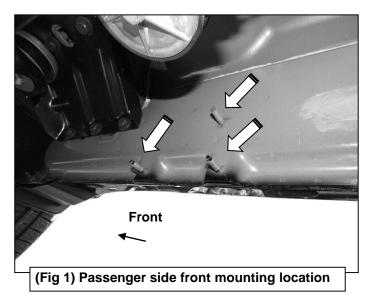
- 1. Start the installation under the passenger side of the vehicle. Locate the front (3) factory studs along the inner side of the body panel, (Figure 1).

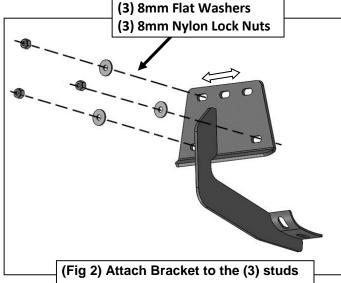
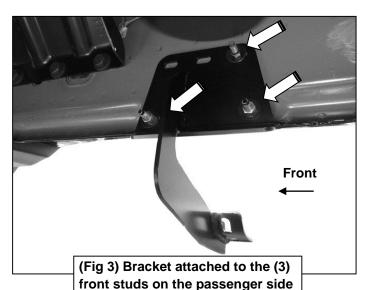
- Select (1) Mounting Bracket. NOTE: All (6) Brackets are universal and will fit left or right side. Attach the Mounting Bracket to the (3) factory studs with (3) 8mm Flat Washers and (3) 8mm Nylon Lock Nuts, (Figures 2 & 3). Leave brackets loose at this time.

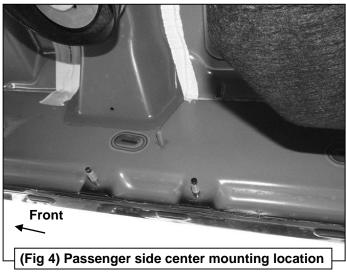
- 3. Repeat **Steps 1 & 2** to install the Universal Brackets in the center and rear mounting locations along the body panel, **(Figure 4—7)**.
- 4. Carefully unwrap and select the Passenger/right Sidebar. Use the illustration above to help identify the correct Sidebar. Place the Sidebar on top of the Brackets. **IMPORTANT**: Do not slide, (front to back or rotate), the Sidebar on the Brackets or damage to the finish on the Sidebar may result.
