3" Bull Bar

Part No. B0034S/B

Fits: 2017-Current Ford Super Duty F250-F350

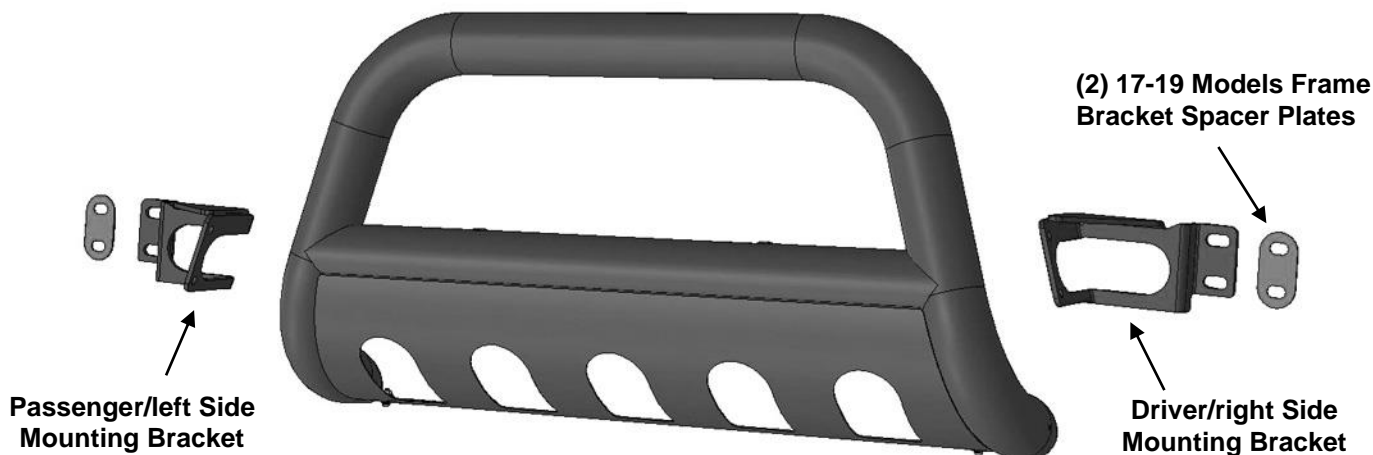
PARTS LIST:

Qty	Part Description	Qty	Part Description
1	Bull Bar	4	10-1.5mm x 30mm Hex Bolts
1	Driver/left Frame Mounting Bracket	8	10mm x 27mm OD x 3mm Flat Washers
1	Passenger/right Frame Mounting Bracket	4	10mm Nylon Lock Nuts
2	Spacer Plates (2017-19 models only)

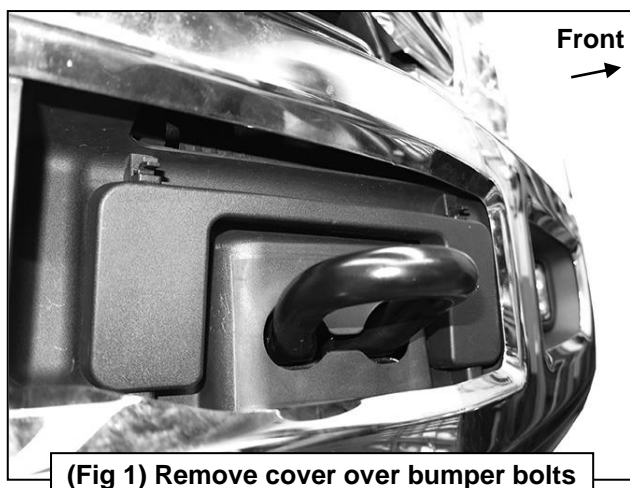
(Fig 1) Remove cover over bumper bolts

1. Start installation at the driver/left side, front of the vehicle. Remove the plastic cover, (if equipped), covering the bumper bolts on both sides of the tow hook, **(Figure 1)**. Remove the (2) outer bumper bolts, **(Figures 2 & 3)**. **IMPORTANT:** Do not remove the inner bumper bolts or the bumper may fall. Only remove the outer bumper bolts. **NOTE:** Cover cannot be reinstalled.

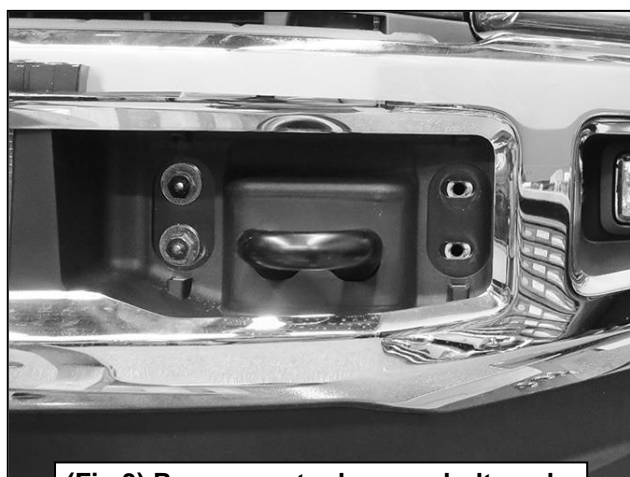
(Fig 3) Remove outer bumper bolts only (driver/left front of bumper pictured)

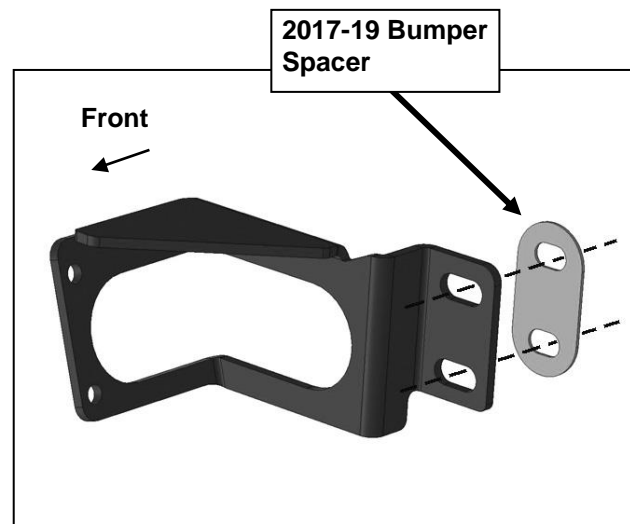
(Fig 4) On 2017-19 models only, attach driver/left Bracket to Spacer and bumper. Do not install Bracket without Spacer on 2017-19 model years

- a. Select (1) Spacer Plate, **(Figure 4)**. Place the Spacer over the holes for the bumper bolts, between the bumper and the Bracket.

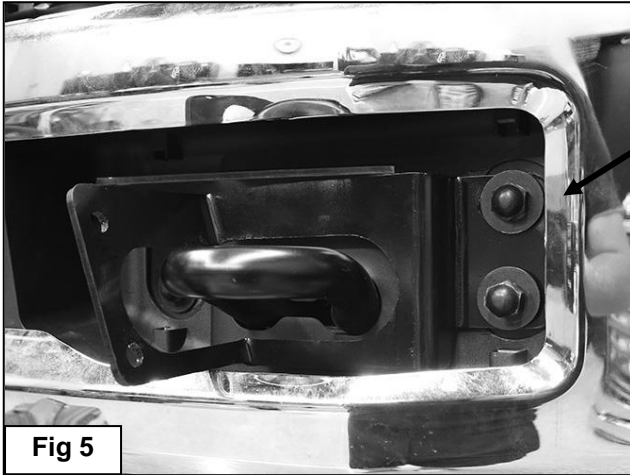
Reuse factory bumper bolts to attach Bracket and Spacer to Bumper

- b. Reuse the factory bumper bolts to attach the Frame Bracket to the Spacer and bumper, (**Figure 5**).

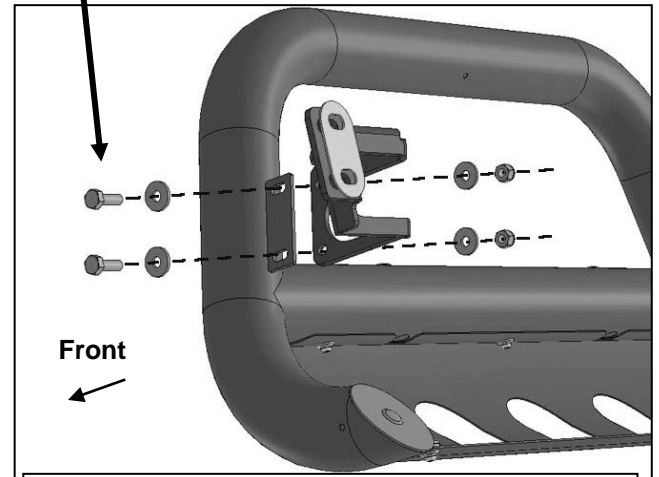
(2) 10mm x 30mm Hex Bolts
(4) 10mm Flat Washers
(2) 10mm Nylon Lock Nuts

(Fig 6) Attach Bull Bar to outside of Brackets

6. Attach the Bull Bar to the outside of the Mounting Brackets using the included (4) 10mm x 30mm Hex Bolts, (8) 10mm Flat Washers, (4) 10mm Nylon Lock Nuts, (**Figures 6 & 7**). Snug but do not tighten hardware at this time.

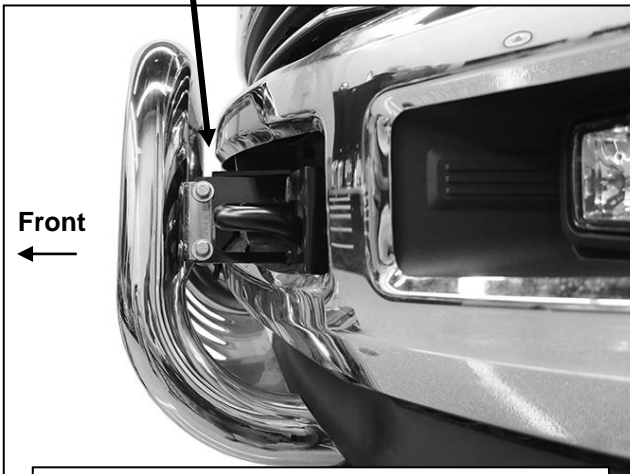
(2) 10mm x 30mm Hex Bolts
(4) 10mm Flat Washers
(2) 10mm Nylon Lock Nuts

(Fig 7) Driver/left side complete installation

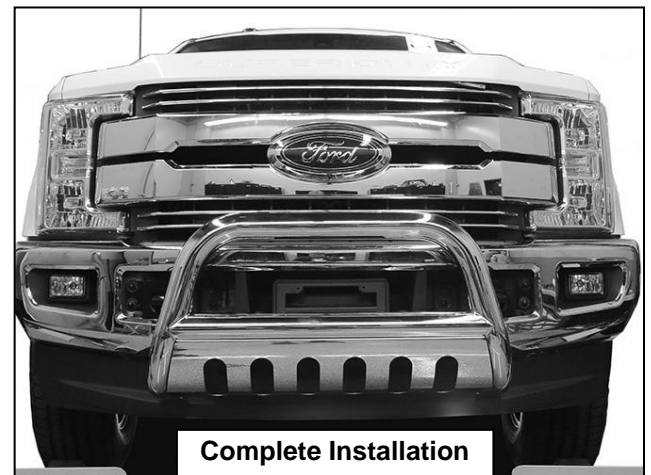
No.	Parts Identification
1	Passenger / Right 'Rear' Bracket marked "PR"
2	Driver / Left 'Rear' Bracket marked "DR"
3	Passenger / Right 'Center' Bracket marked "PC"
4	Driver / Left 'Center' Bracket marked "DC"
5	Passenger / Right 'Front' Bracket marked "PF"
6	Driver / Left 'Front' Bracket marked "DF"

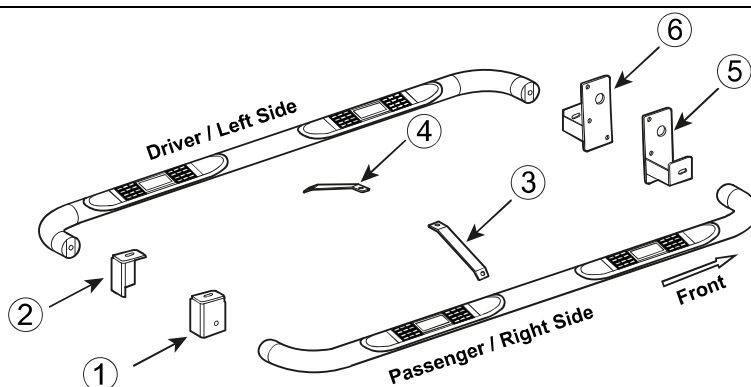
- This guide is to identify the parts and not a reference for part count.
- For part count, refer Parts List.
- Product / Bracket image is representative and actual design may vary.
